Overview

Company: AeroSurvey Solutions Ltd **Inspection Consultant:** Mr Allen

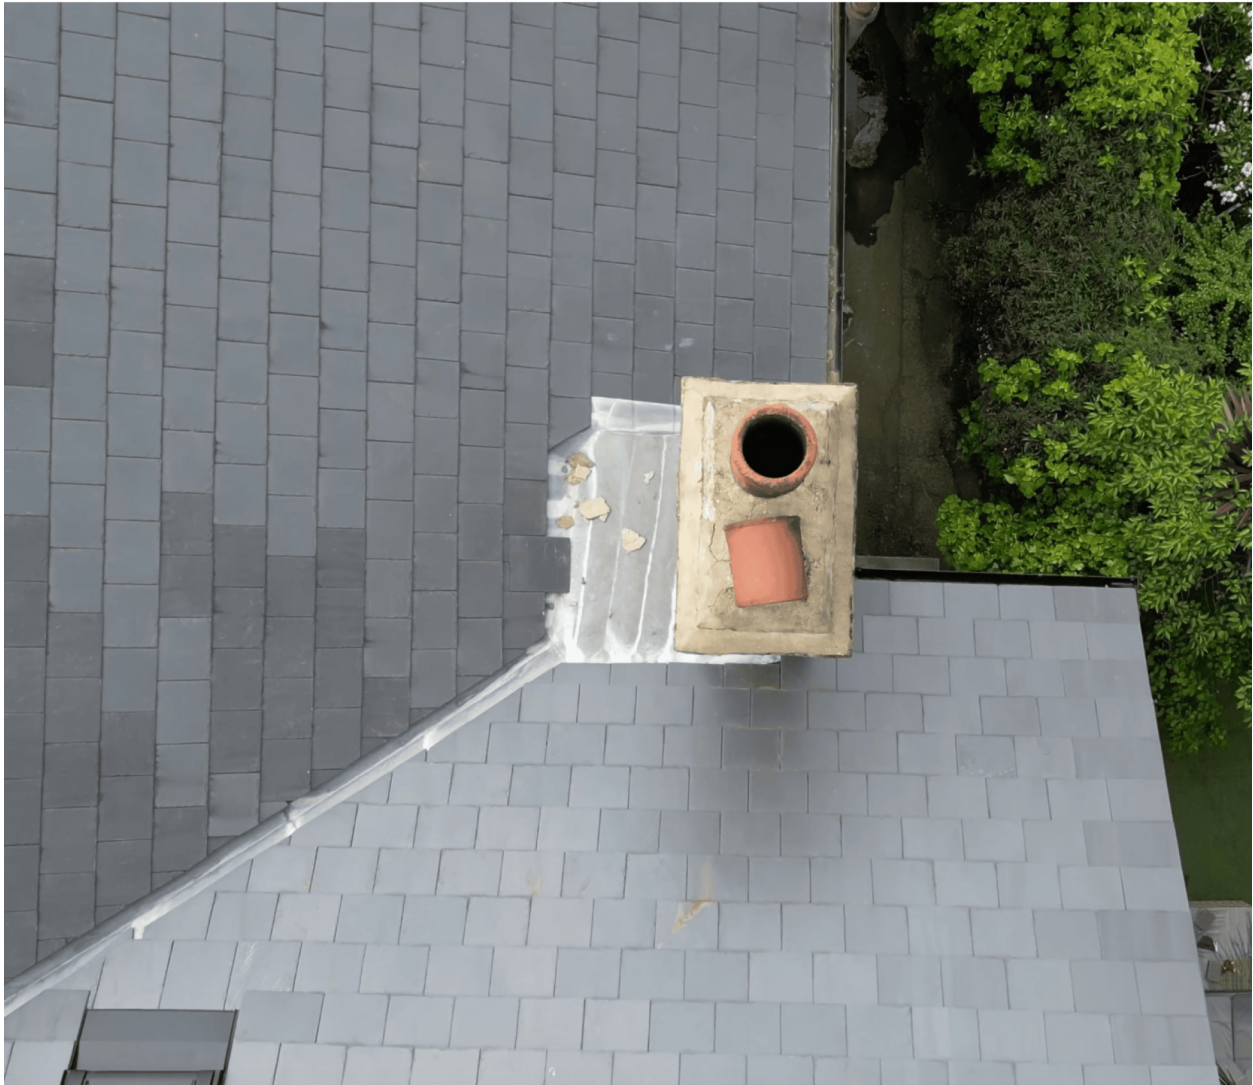
secure flashing. However, there are some concerns evident in **Image C1**, specifically around the chimney structure. While the roof itself does not show any significant issues, the area around the chimney requires prompt attention to prevent future complications.

1. Chimney Condition (Image C1):

- The chimney presents a few visible issues that require immediate attention. One of the clay chimney pots is damaged and appears to be displaced from its proper position. This could result in water ingress if not addressed, as the chimney is a key entry point for moisture.
- Additionally, some mortar or masonry debris is visible around the chimney base, indicating potential weathering or degradation of the chimney structure.
- The flashing around the chimney appears secure, but given the debris and potential deterioration of the masonry, further inspection is recommended to ensure that no underlying damage is present.

3. Debris Around the Chimney:

- The debris visible around the chimney, as seen in **Image C1**, suggests potential degradation of the chimney structure. While the roof tiles are not directly

impacted, the loose masonry could lead to more serious issues if left unattended. Prompt cleaning and repair of the damaged chimney materials are necessary.

1. Chimney Repairs:

- The damaged chimney pot should be replaced or repositioned to prevent water ingress and ensure the integrity of the chimney.
- The debris surrounding the chimney should be cleared, and an inspection of the mortar and chimney structure should be performed to identify any further deterioration. Repointing of the chimney mortar may be required to prevent future weather-related issues.
