Client: Mrs Christopher

Address: 11 Bury Road W20 7LQ

Overview

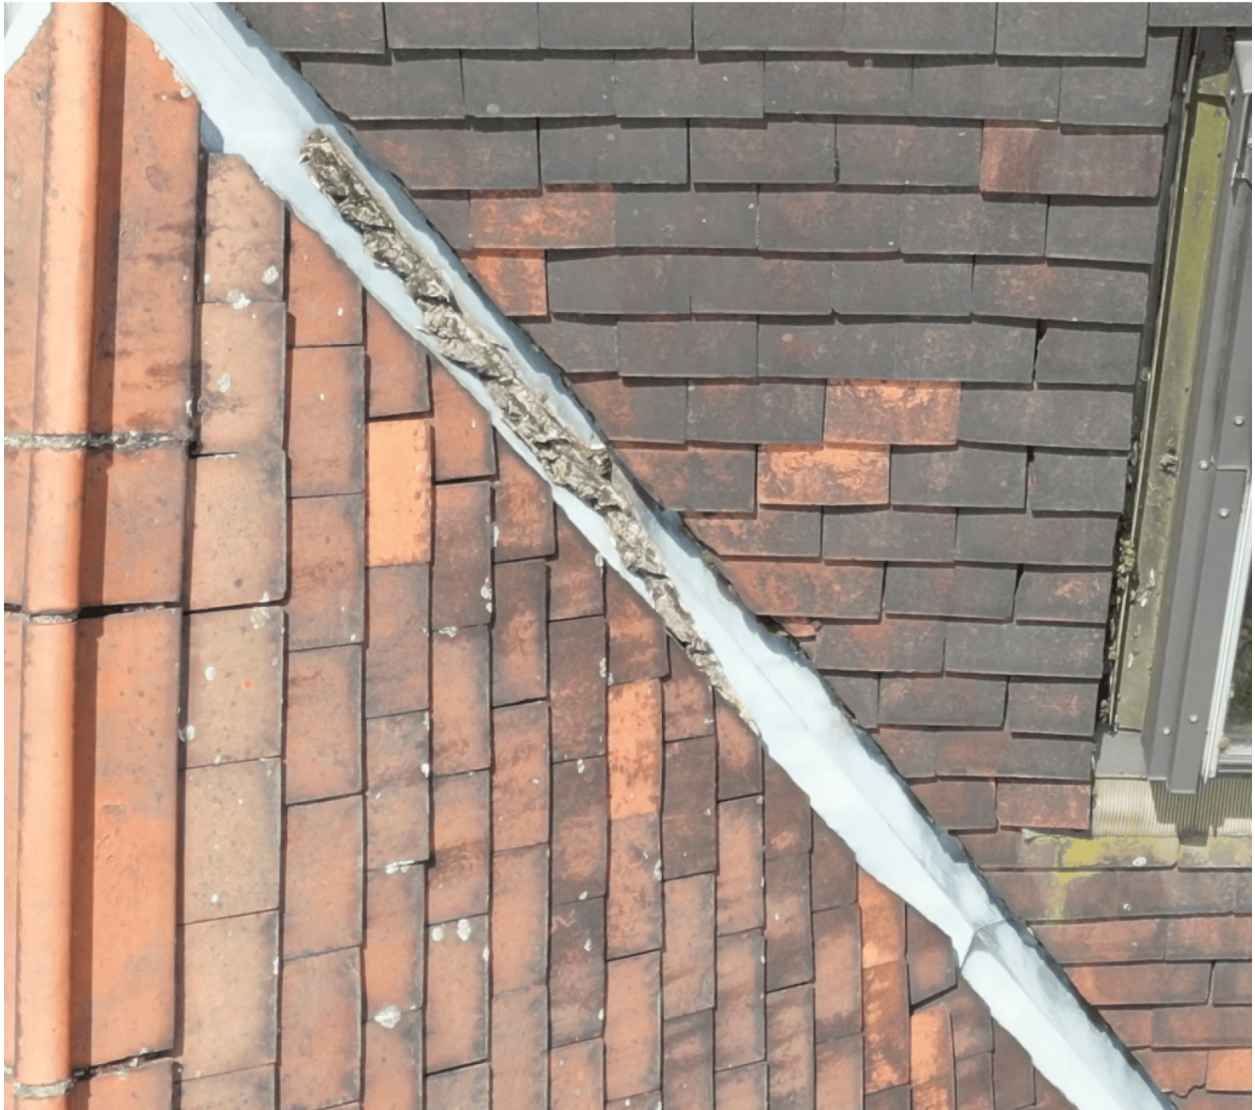
- **Image D1** shows missing or deteriorated mortar along the ridge tiles, with visible gaps where structural stability is compromised. The storm may have exacerbated existing weaknesses, leaving exposed areas vulnerable to water ingress. Repointing and resealing these ridge tiles are recommended to restore full integrity.
- In **Image D4**, similar issues are visible, with sections of the ridge showing broken or loose tiles. These gaps could lead to additional damage if not addressed, especially in future weather events.

- Across the images, particularly in **D1** and **D2**, moss and lichen growth are present on the roof tiles and in the valleys. While this growth may predate the storm, moisture retention from recent rainfall can accelerate the degradation of the tiles, leading to further damage if not removed.

- Repoint the mortar along the ridge tiles seen in **Images D1** and **D4** to restore stability and prevent water ingress. Loose or broken ridge tiles should be refitted or replaced as necessary to secure the structure against future storms.

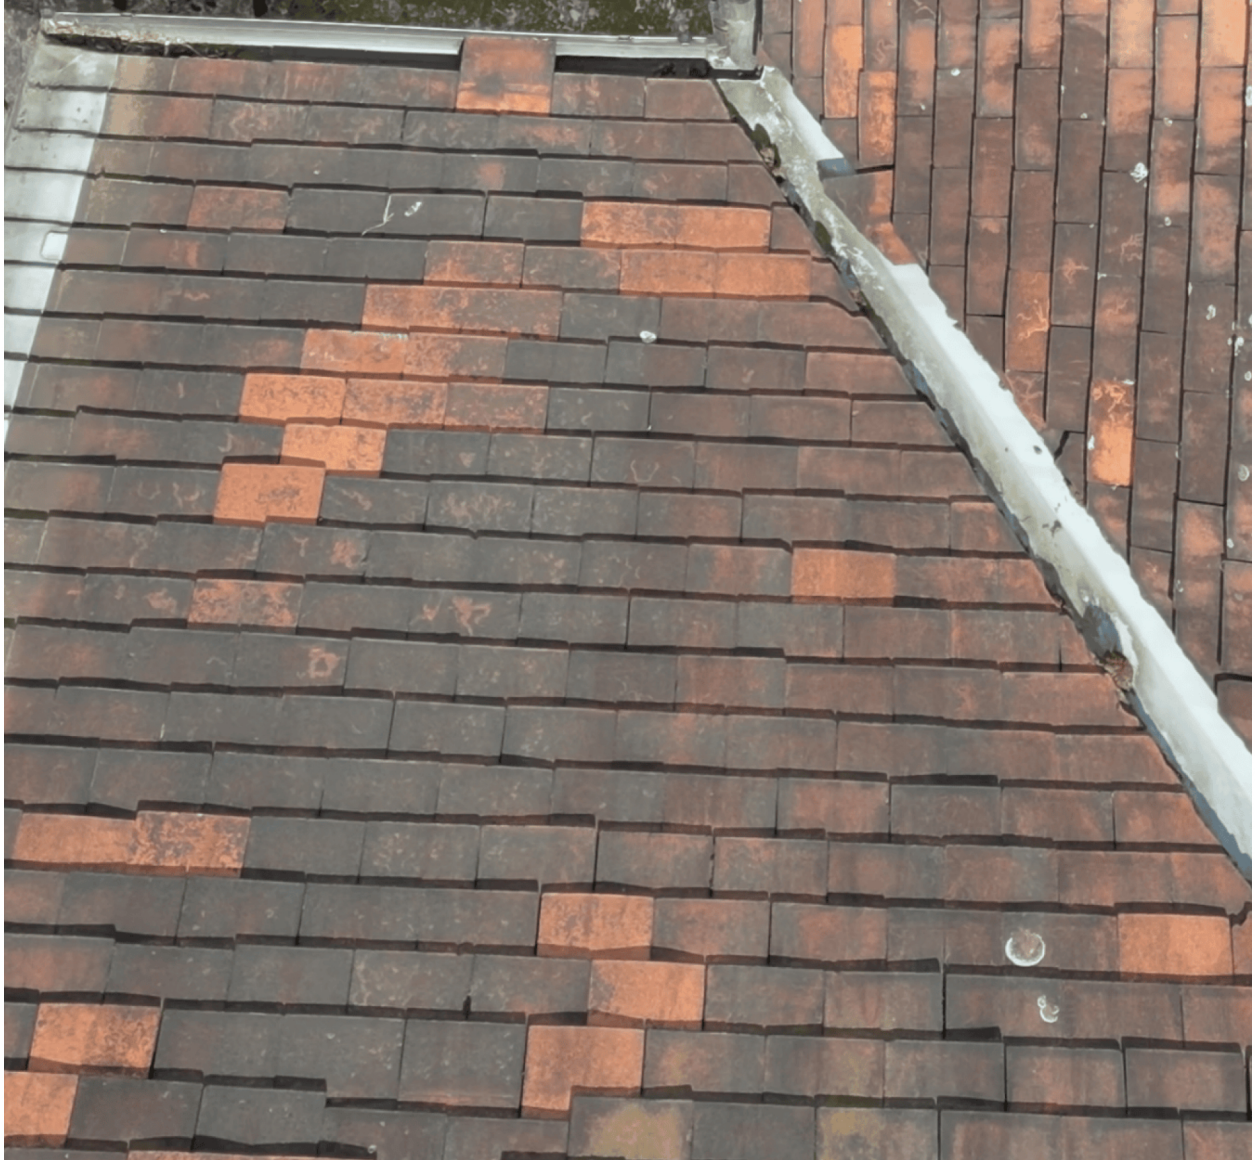
- **Image D2** highlights accumulated debris within the valley, likely worsened by the recent storm. Debris buildup can obstruct water flow, leading to pooling and potential leaks. Clearing the valley of moss, leaves, and other materials is necessary to ensure effective drainage.
- **Image D3** shows a deteriorated valley with visible moss and other biological growth along the edges. The storm may have contributed to further loosening of materials in this area, and a thorough cleaning followed by an inspection of the valley flashing is recommended to maintain watertightness.

- The valleys, especially those shown in **Images D2** and **D3**, should be cleared of all moss, debris, and any storm-related materials. This will prevent obstructions and ensure proper drainage. After clearing, inspect the valley flashing for any signs of damage or wear, particularly where storm impact may have exacerbated weaknesses.

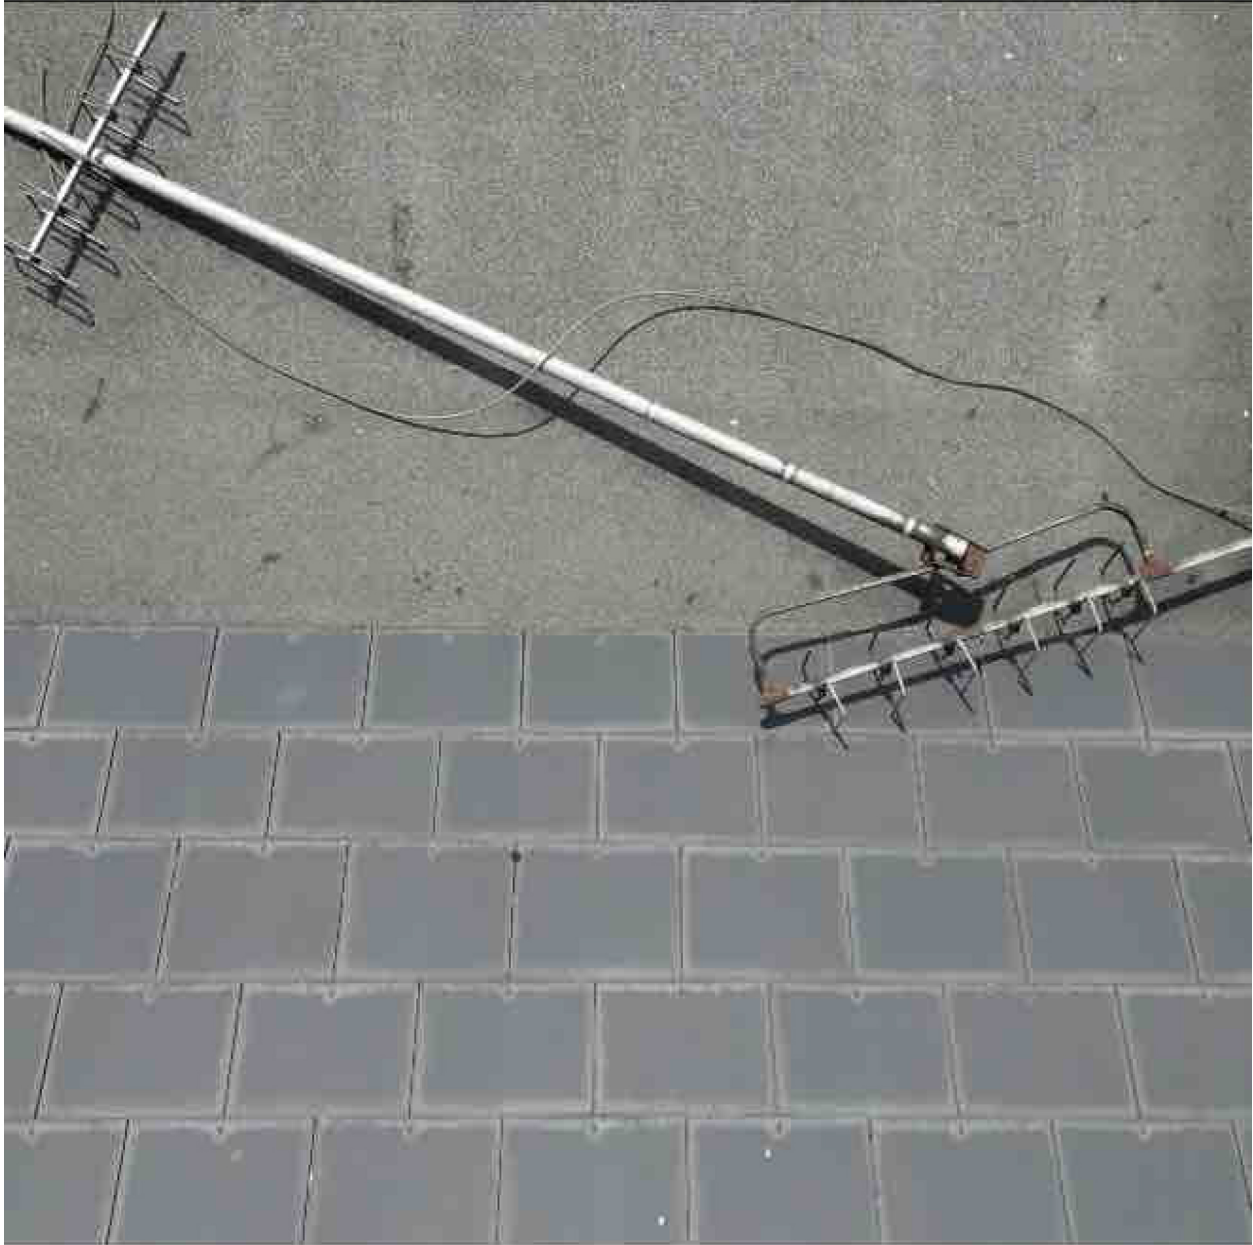
- **Image D5** shows a fallen or dislodged antenna lying across the roof surface. This likely occurred during the recent storm and presents multiple risks. The loose antenna can cause physical damage to the tiles beneath it and create puncture points where water might infiltrate. Additionally, the associated wiring is exposed and may have been compromised, presenting a potential electrical hazard.
- The roofing surface beneath the antenna appears intact, but further inspection is recommended after the antenna and wiring are removed to ensure no hidden damage exists.

- The dislodged antenna should be safely removed from the roof, along with any exposed wiring, to prevent further physical or electrical hazards. Once removed, inspect the roof surface beneath for any signs of damage. Reinstalling the antenna securely, ideally in a more storm-resistant configuration, is recommended if the equipment is still in use.
