Client: [REDACTED]

Address: [REDACTED]

Overview

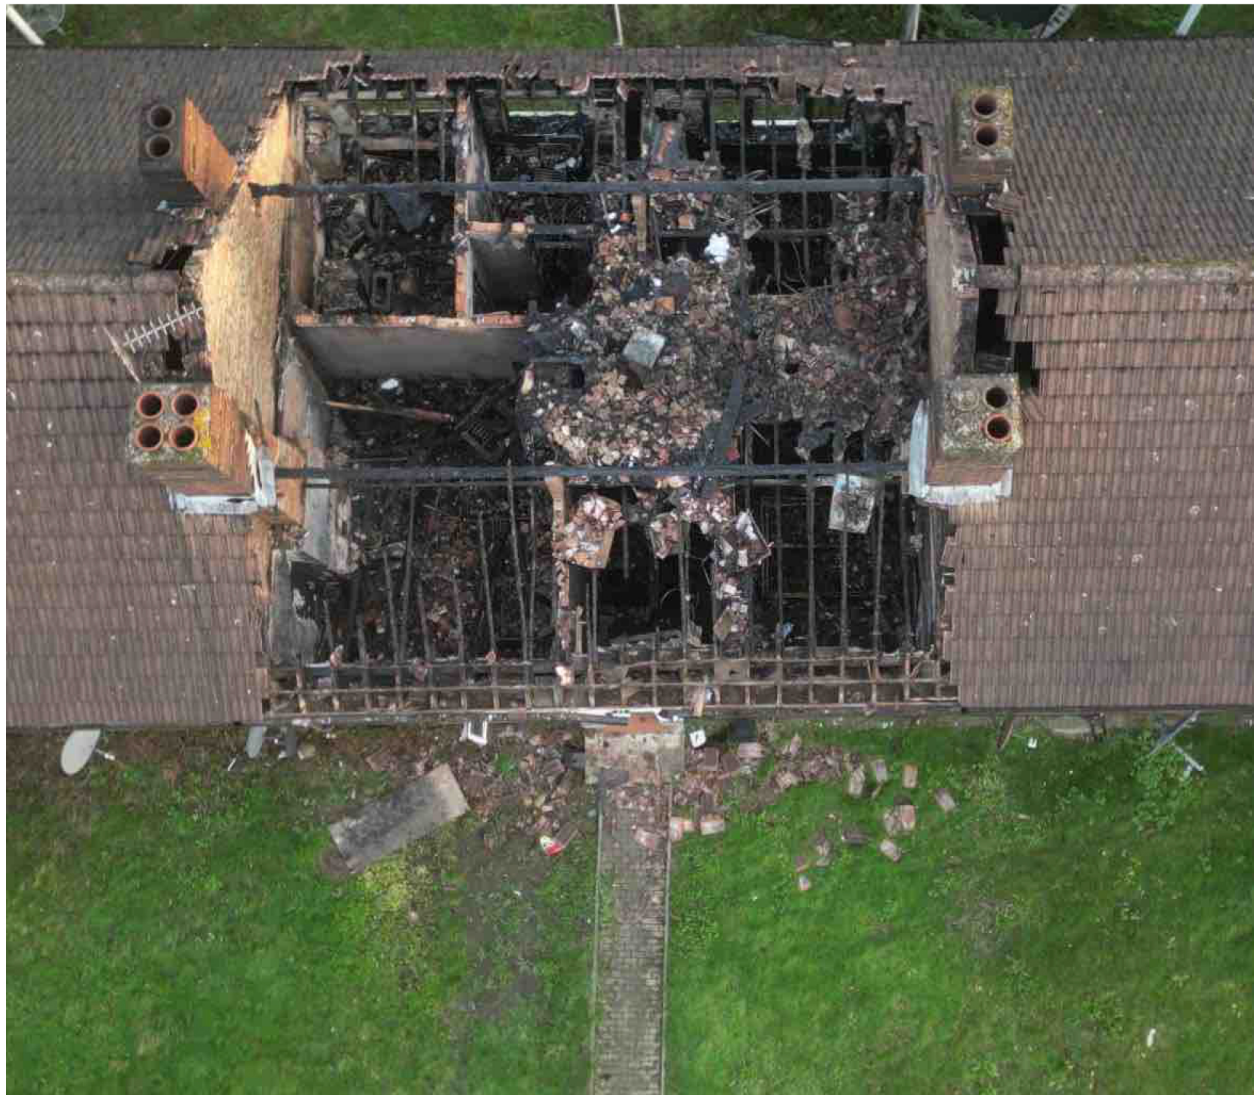
- **Image H1** shows extensive fire damage to the roof, with sections of roof tiles

entirely missing, exposing the underlying structure. Charred beams and broken tiles indicate severe compromise to the roof's structural stability. The large gaps left by destroyed materials suggest that the roof can no longer provide adequate shelter or support.

- **Images H1** and **H3** show that the chimney stacks remain upright, despite the extensive damage around them. There is minor visible charring near the chimneys, but the stacks themselves do not show signs of imminent collapse from the fire. However, high temperatures may have affected the brickwork and mortar, potentially weakening these structures.
- Given the thermal stress endured, the stability of the chimneys should be professionally evaluated to ensure they have not been compromised, especially where mortar may have weakened due to heat exposure.

- The roof tiles surrounding the heavily damaged areas in **Images H1** and **H3** may also be at risk, given the structural instability of the roof beneath them. Even tiles that appear intact might have been compromised by the heat and could dislodge under adverse weather conditions or during any repair process.

- A full structural assessment is essential to evaluate the safety of the remaining roof framework and chimney stacks. Any unstable sections should be safely demolished to prevent further collapse, particularly where charred beams are visibly damaged, as seen in **Images H1** and **H2**.

- Although the chimneys appear structurally intact in **Images H1** and **H3**, a professional stability assessment is recommended. Thermal stress from the fire may have weakened mortar joints, which may not be immediately apparent. Repointing or reinforcement may be required if any structural weaknesses are identified.

- The surrounding tiles, especially those visible in **Images H1** and **H3**, should be inspected for any heat damage and replaced as needed to ensure a stable, safe roof once reconstruction is complete.

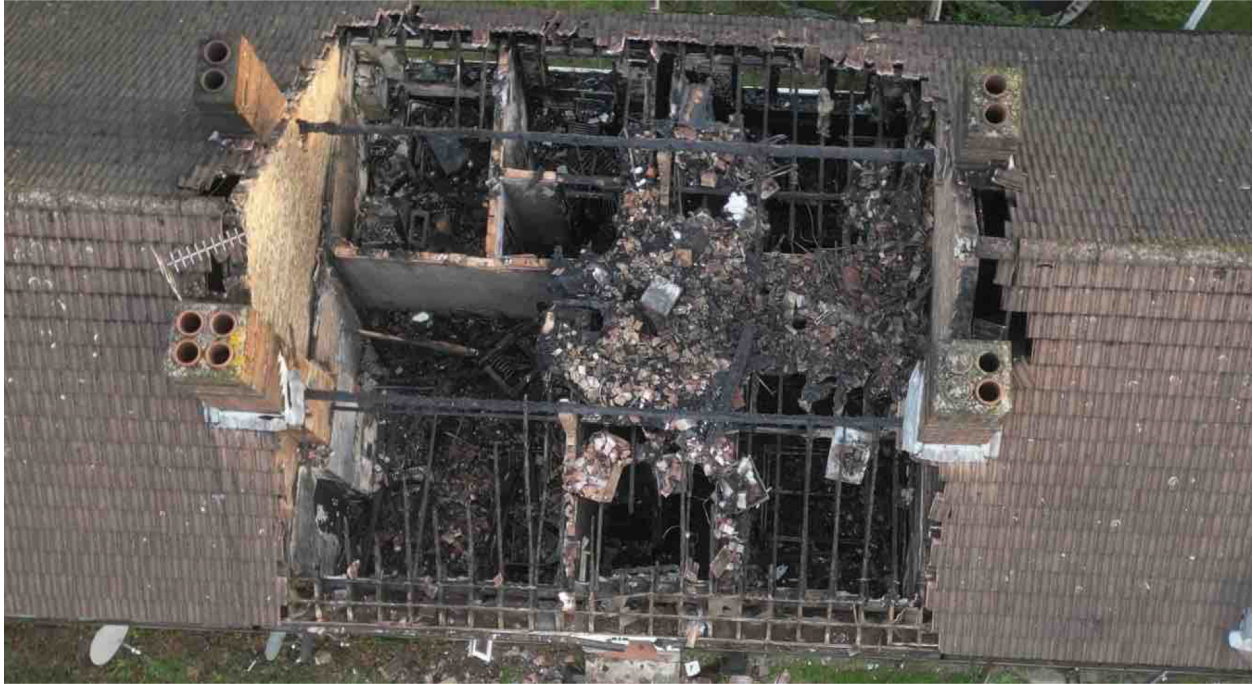
- Visible charring and extensive damage to the roof in **Image H2** further highlight the structural risks. The missing roofing materials and timber beams leave the interior exposed to the elements, and any remaining sections of the roof likely lack sufficient integrity, presenting a risk of collapse if left unsupported.

- **Image H2** provides a clear view of the interior framework supporting the roof, which appears extensively charred, with multiple sections entirely missing. The remaining beams are visibly compromised, likely rendering them structurally unsound. This level of destruction indicates that most, if not all, of the internal roofing structure will need to be replaced.
- The interior is littered with collapsed materials and debris, indicating a need for thorough debris removal before a complete structural assessment can be conducted. This includes removing charred beams, loose tiles, and any other

remnants that may no longer serve a functional purpose.

- The extensive debris seen in **Image H2** should be carefully cleared, including charred wood, broken tiles, and other structural remnants. This will allow a thorough inspection and mitigate the risks associated with falling materials.
