Address: 58 Station Road N3 2SA

Roof Type: Tile Hipped

Date & Time: 16th July 2025 - 11:00hrs

## **Roof Inspection Report:**

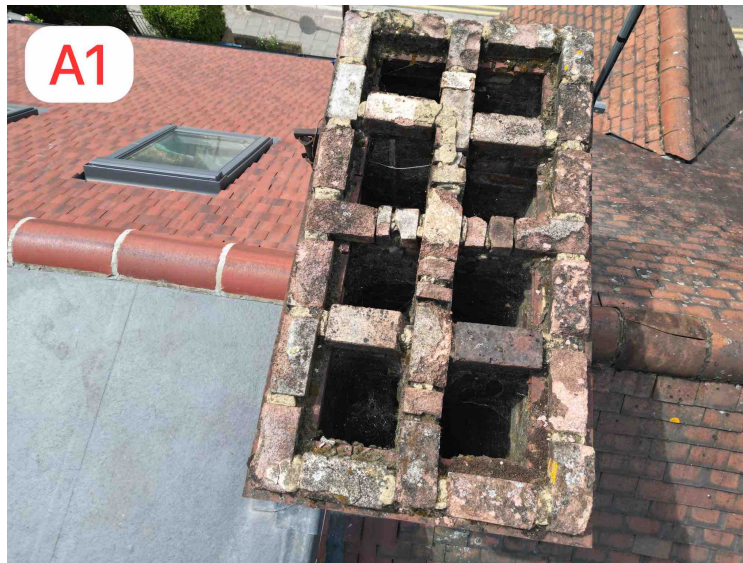
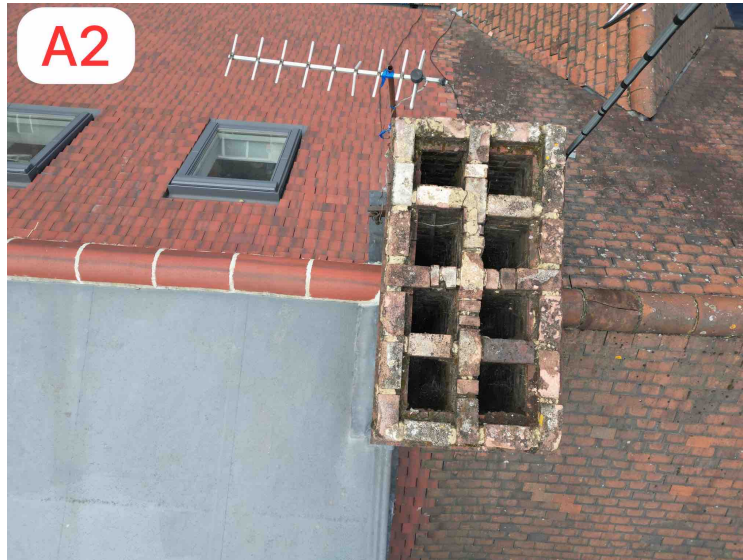
### **1. Chimney Stack (Neighbouring Property) – Images A1 & A2**

- The neighbouring chimney stack is missing a chimney cowl.
- This may allow rainwater ingress into the flue, potentially causing internal dampness along the adjoining chimney breast wall.
- The absence of a cowl also increases the likelihood of bird nesting within the flue, which could cause blockages or internal ventilation issues.
- The internal pointing within the stack appears to have deteriorated due to prolonged exposure to the elements.

The neighbour should be advised to fit a cowl to prevent water penetration and bird ingress. Repointing of the chimney stack is also advised to prevent further degradation.

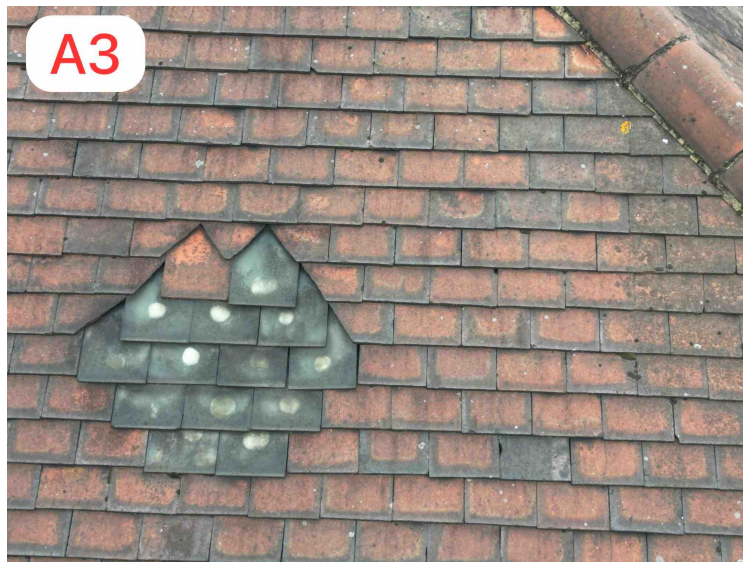
#### **5. Previous Roof Repairs – Image A3**

- Evidence of historic tile replacement observed.
- No immediate defects visible and the repairs appear sound with no signs of displacement or gaps.

Monitor as part of routine maintenance.

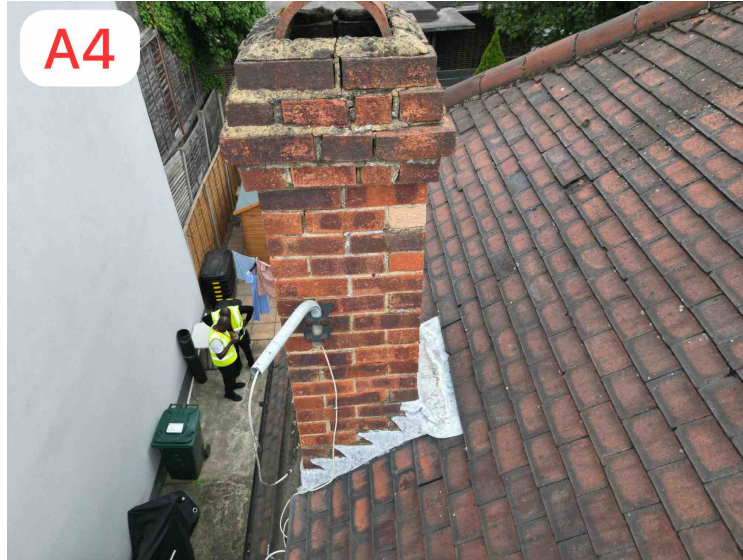
## 6. Chimney Stack (Client's Property) – Image A4

- The secondary chimney stack to the rear is capped and overall appears in sound structural condition.
- Minor deterioration in mortar pointing observed on some faces.

Localised repointing to prevent water ingress and preserve chimney integrity.

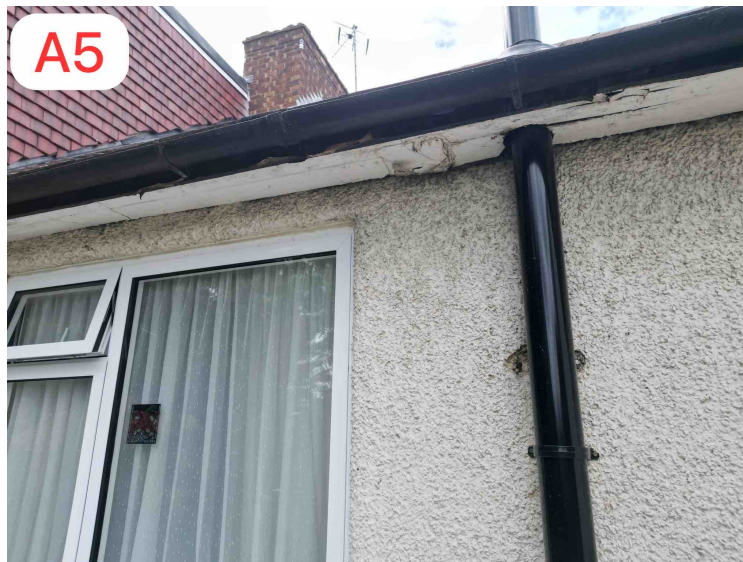
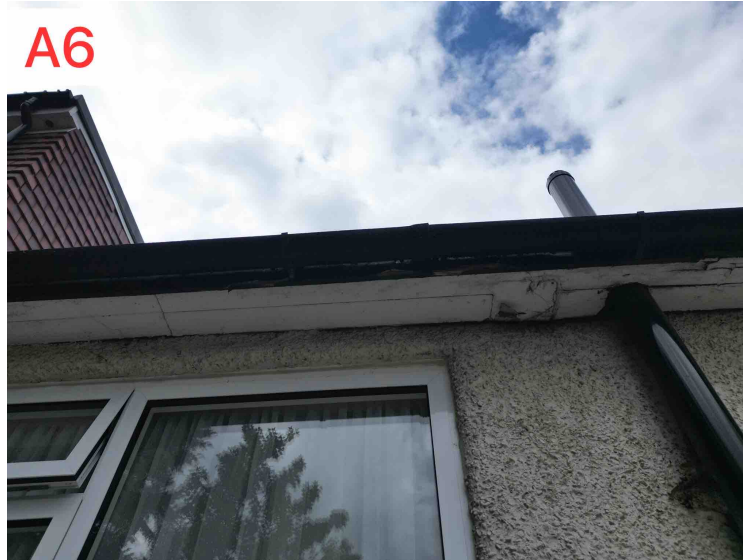
## 2. Guttering and Fascia Board – Images A5 & A6

- Guttering to the rear elevation appears to be in poor condition, with clear evidence of water damage to the fascia and soffit beneath.
- This is likely the contributing factor to the reported bathroom leak and poses a longer-term risk of damp ingress if not rectified.

Urgent repair or replacement of the damaged guttering and repair of the underlying fascia/soffit. Ensure water is being adequately diverted away from the building fabric.

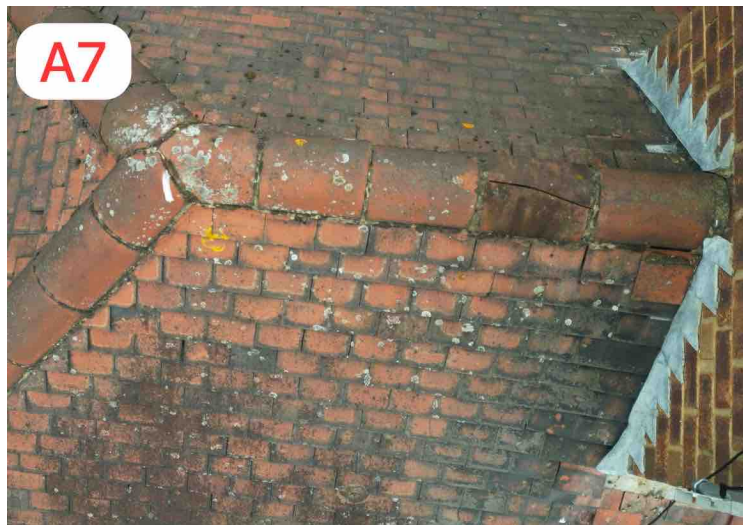
#### **4. Cracked Ridge Tile – Image A7**

- A visible fracture is present along a ridge tile near a hip junction.
- Although currently intact, this may deteriorate further and eventually allow water ingress through the ridge line.

Replace the cracked tile to maintain a continuous waterproof seal along the ridge.

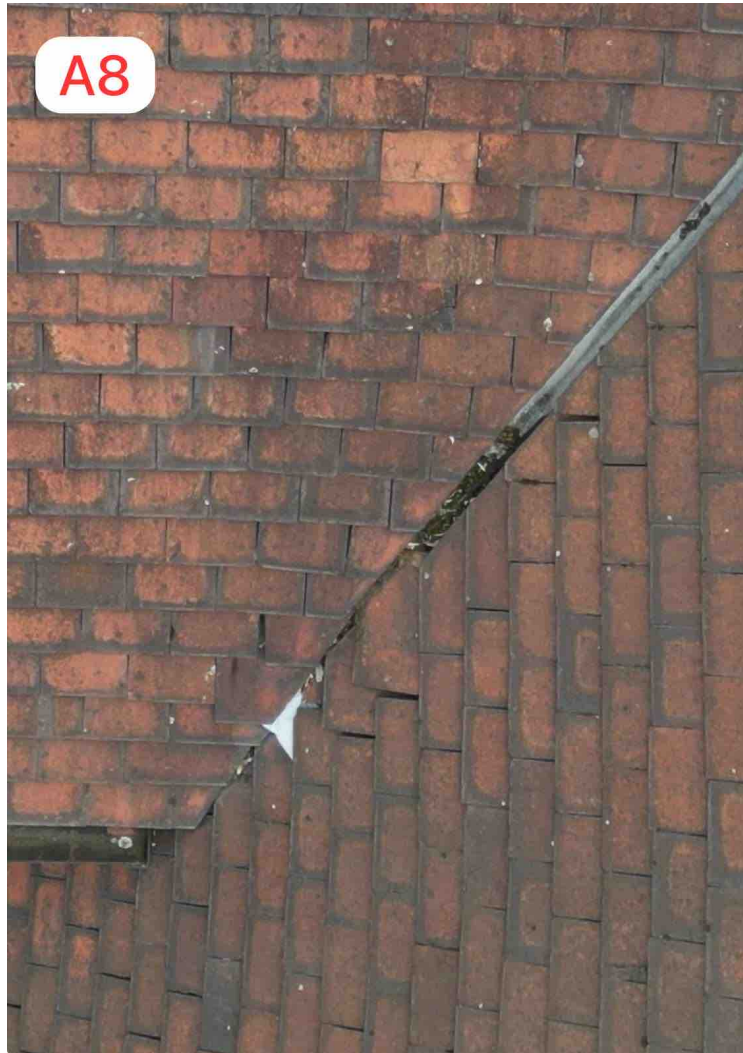
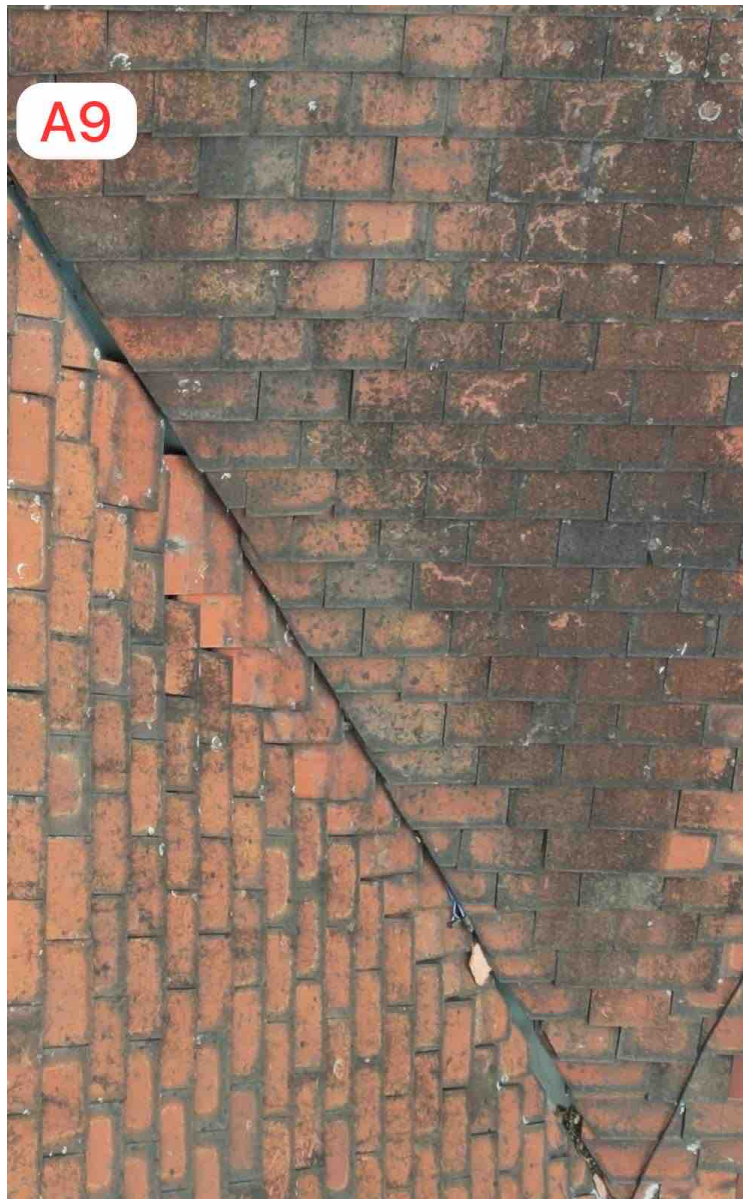
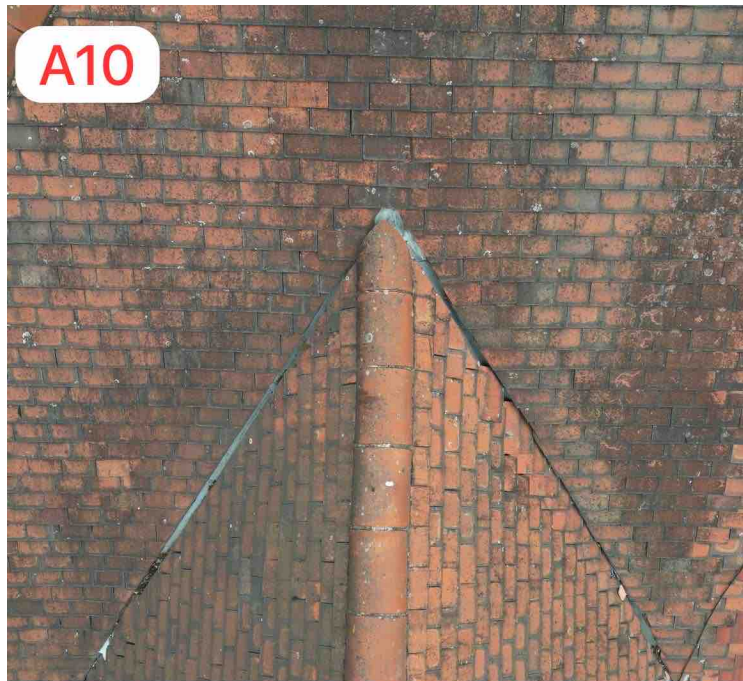
## 3. Dislodged Tiles in Lead Guttering – Images A8 & A9 A10

- Multiple roof tiles have slipped and become lodged within the lead-lined valley gutter.
- This obstruction can prevent the proper flow of rainwater, potentially leading to water pooling and overflow, increasing the risk of water ingress at lower roof junctions.

Immediate removal of all loose or displaced tiles from the gutter. Reposition and secure any tiles at risk of slipping. Inspect the leadwork for possible impact damage.

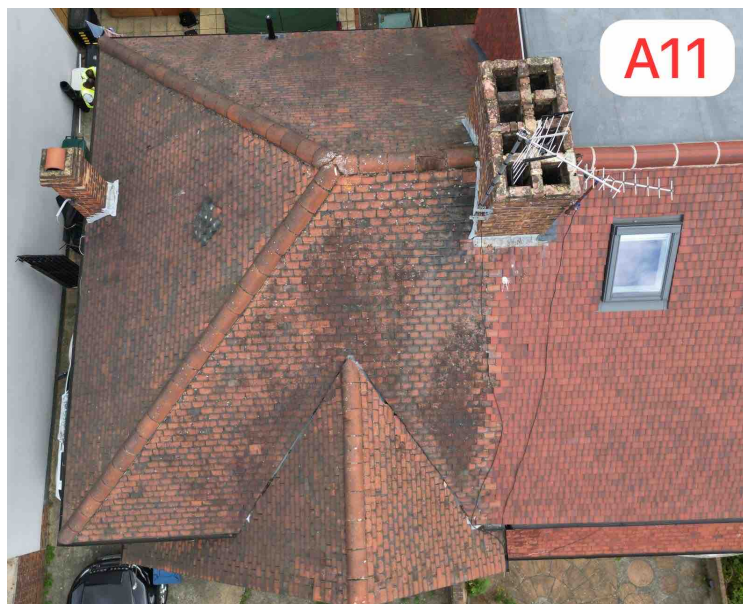
## 7. General Roof Condition – Image A11

- The main roof area is generally in good order with no missing tiles.
- Some chipped tiles were observed, however, they do not compromise the waterproof envelope and present no open gaps or exposed underlay.
- All leadwork visible appears to be in serviceable condition with no lifting, cracking or displacement noted.

No urgent remedial action required. Recommend routine maintenance checks to monitor minor defects.
