Roof Type: Tile Hipped

Date & Time: 16th July 2025 - 11:00hrs

## **Roof Inspection Report:**

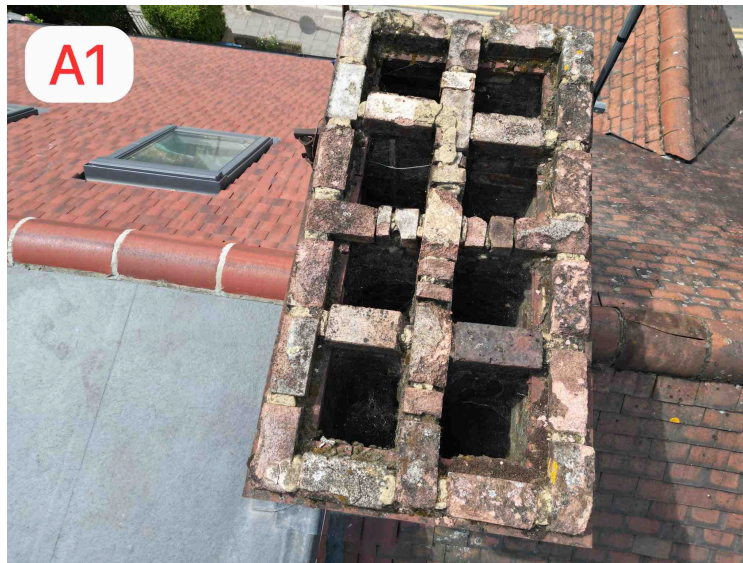
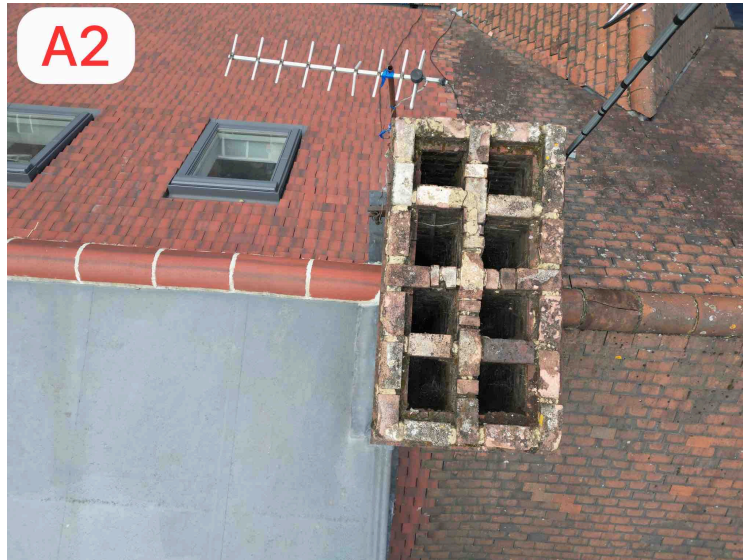
### **1. Chimney Stack (Neighbouring Property) – Images A1 & A2**

- The neighbouring chimney stack is missing a chimney cowl.
- This may allow rainwater ingress into the flue, potentially causing internal dampness along the adjoining chimney breast wall.
- The absence of a cowl also increases the likelihood of bird nesting within the flue, which could cause blockages or internal ventilation issues.
- The internal pointing within the stack appears to have deteriorated due to prolonged exposure to the elements.

The neighbour should be advised to fit a cowl to prevent water penetration and bird ingress. Repointing of the chimney stack is also advised to prevent further degradation.

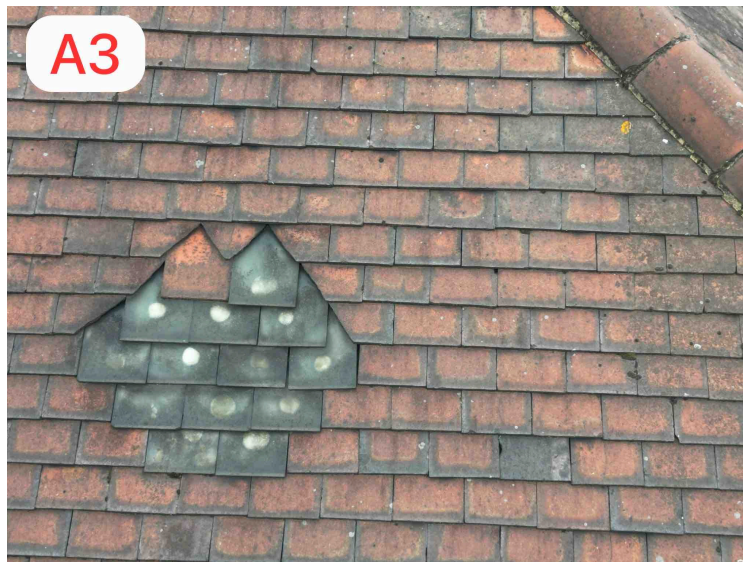
#### **5. Previous Roof Repairs – Image A3**

- Evidence of historic tile replacement observed.
- No immediate defects visible and the repairs appear sound with no signs of displacement or gaps.

Monitor as part of routine maintenance.

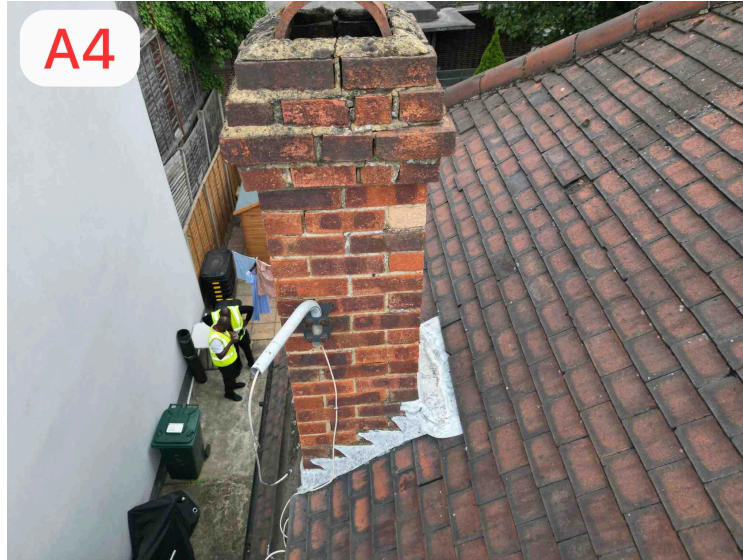
## 6. Chimney Stack (Client's Property) – Image A4

- The secondary chimney stack to the rear is capped and overall appears in sound structural condition.
- Minor deterioration in mortar pointing observed on some faces.

Localised repointing to prevent water ingress and preserve chimney integrity.

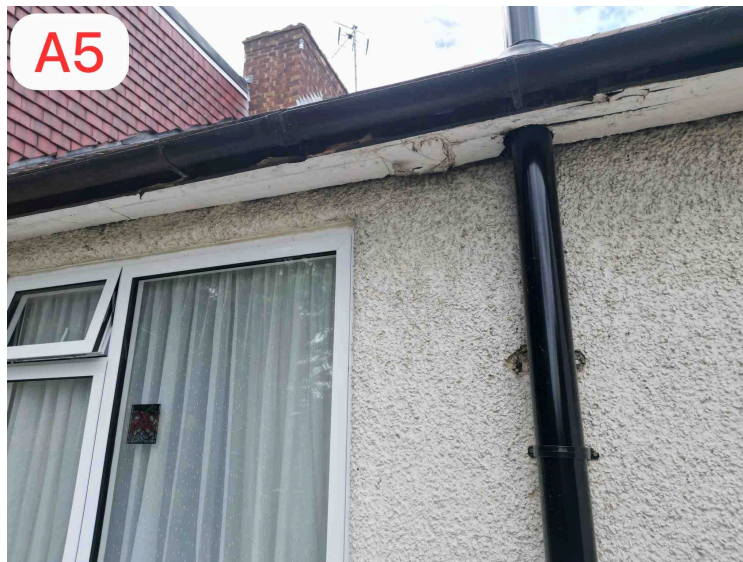
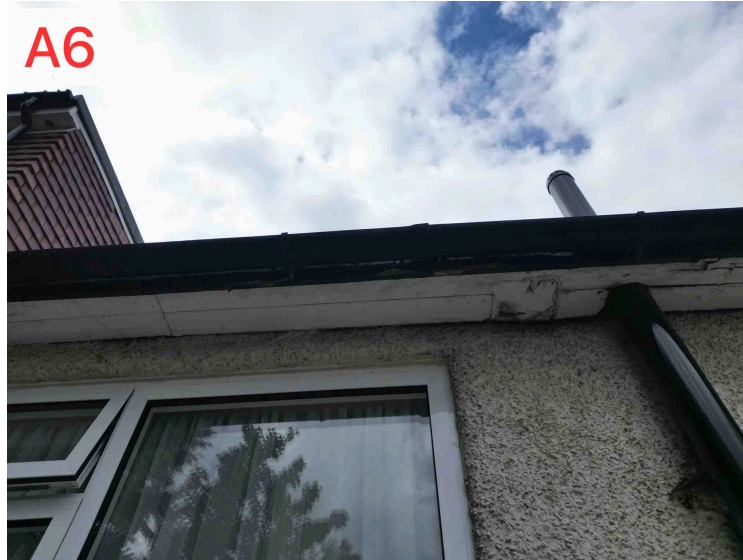
## 2. Guttering and Fascia Board – Images A5 & A6

- Guttering to the rear elevation appears to be in poor condition, with clear evidence of water damage to the fascia and soffit beneath.
- This is likely the contributing factor to the reported bathroom leak and poses a longer-term risk of damp ingress if not rectified.

Urgent repair or replacement of the damaged guttering and repair of the underlying fascia/soffit. Ensure water is being adequately diverted away from the building fabric.

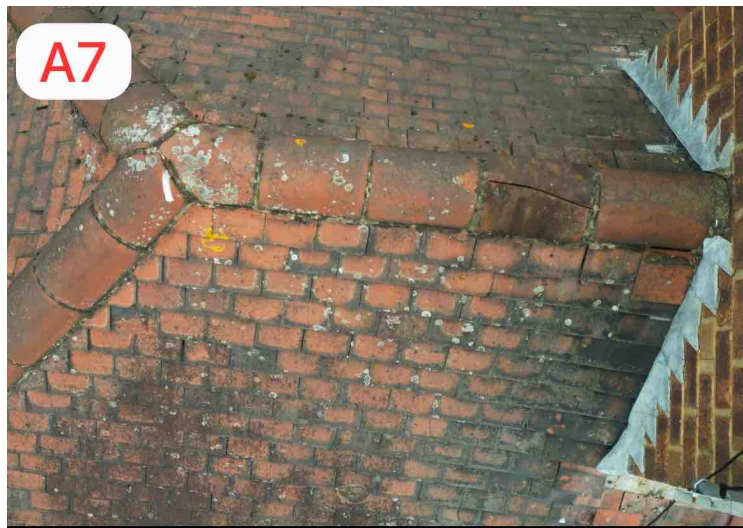
#### **4. Cracked Ridge Tile – Image A7**

- A visible fracture is present along a ridge tile near a hip junction.
- Although currently intact, this may deteriorate further and eventually allow water ingress through the ridge line.

Replace the cracked tile to maintain a continuous waterproof seal along the ridge.

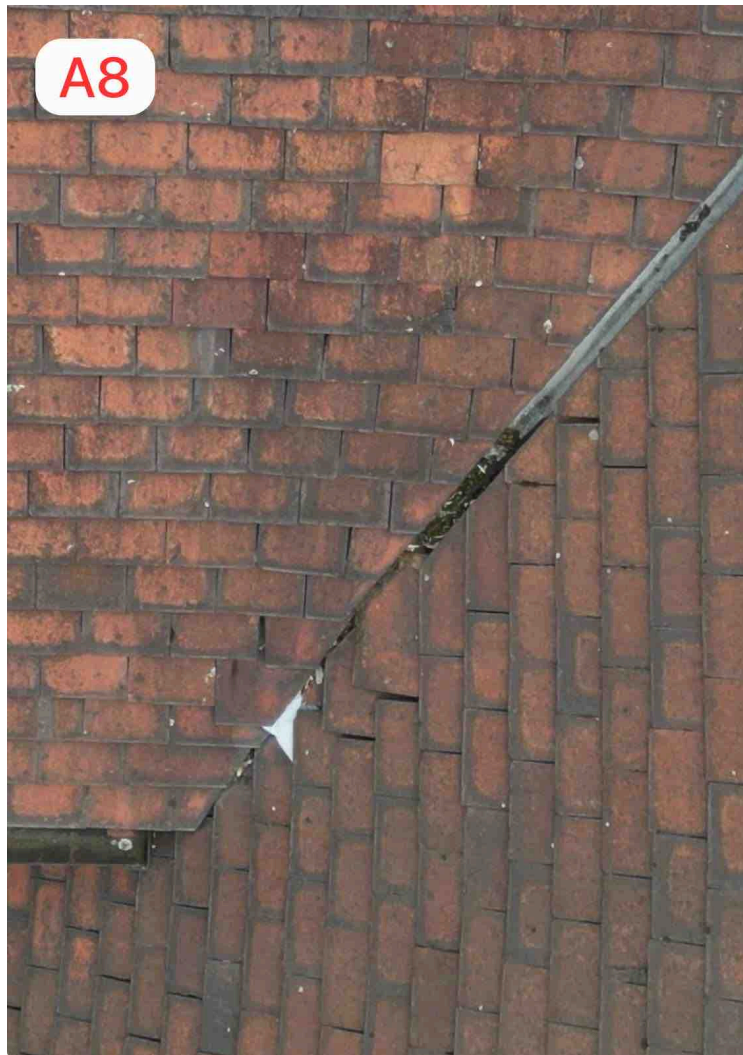
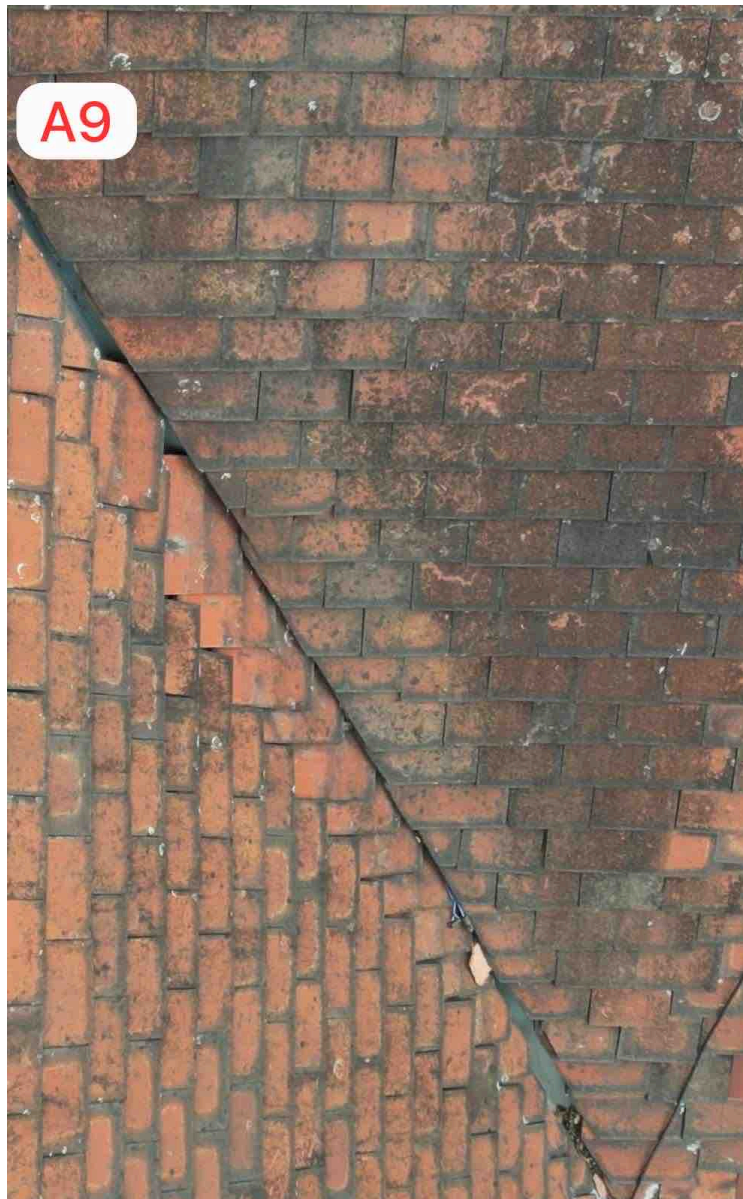
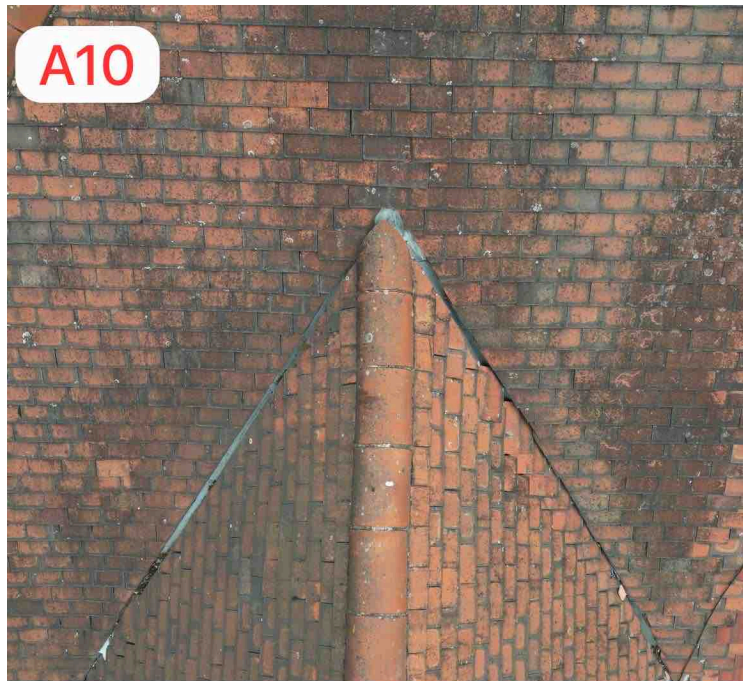
## 3. Dislodged Tiles in Lead Guttering – Images A8 & A9 A10

- Multiple roof tiles have slipped and become lodged within the lead-lined valley gutter.
- This obstruction can prevent the proper flow of rainwater, potentially leading to water pooling and overflow, increasing the risk of water ingress at lower roof junctions.

Immediate removal of all loose or displaced tiles from the gutter. Reposition and secure any tiles at risk of slipping. Inspect the leadwork for possible impact damage.

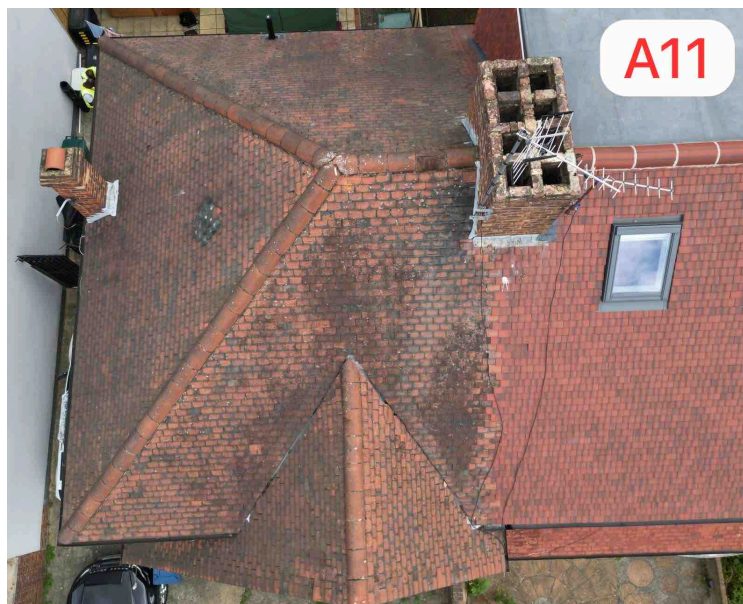
## 7. General Roof Condition – Image A11

- The main roof area is generally in good order with no missing tiles.
- Some chipped tiles were observed, however, they do not compromise the waterproof envelope and present no open gaps or exposed underlay.
- All leadwork visible appears to be in serviceable condition with no lifting, cracking or displacement noted.

No urgent remedial action required. Recommend routine maintenance checks to monitor minor defects.
