**Roof Type:** Flat

### **Purpose of Inspection**

On the 23rd of February 2026, we attended the above property to conduct a drone assisted roof inspection for insurance purposes. The client required an independent condition assessment of the flat roof covering to support an application for an insurance policy. The inspection was undertaken to document the current condition of the roof and identify any visible defects.

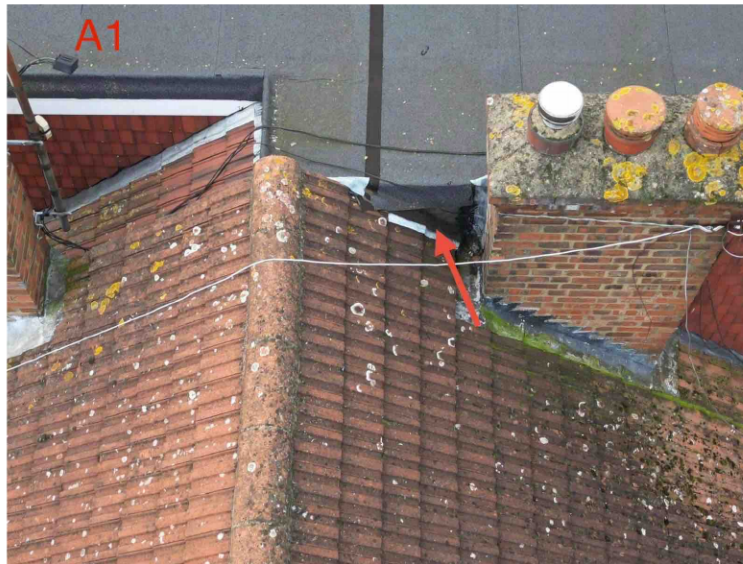
### **Photo A1**

The arrow highlights a localised section of bitumen felt at an abutment junction which does not appear to be fully adhered to the substrate. A slight lift is visible along the edge detail. At the time of inspection, the membrane remains in position with no evidence of tearing, splitting, or open seam formation.

Whilst presently stable, this area may be susceptible to wind uplift during periods of strong weather. Continued exposure to high winds could result in progressive lifting if left unaddressed. This is considered a minor, non structural defect and does not currently compromise the waterproof integrity of the roof covering. A preventative localised bonding repair is recommended to mitigate future risk.

One minor area of incomplete bonding has been identified Photo A1. This is a non structural defect and does not presently compromise the waterproof integrity of the roof covering, though preventative repair is advised.

- Carry out a localised bonding repair to the area highlighted in Photo A1 as a preventative measure.
- Clear moss and debris from guttering as part of routine maintenance.
- No further remedial works are required at this time based on the visible condition of the roof covering.

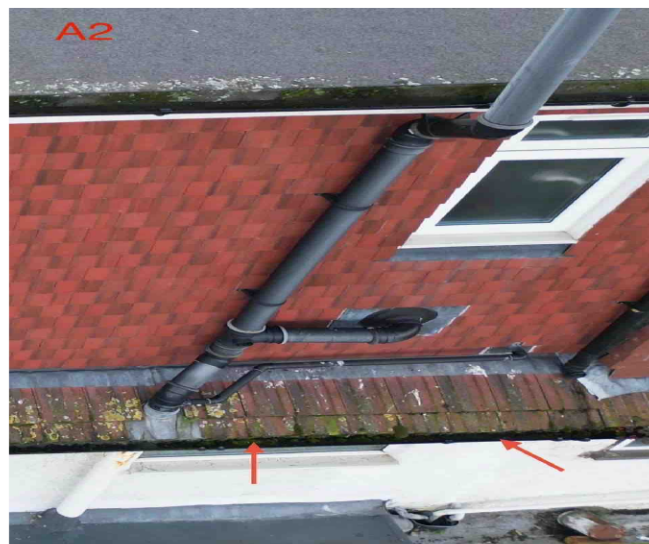
### Photo A2

The arrows indicate moss accumulation within the guttering below the flat roof edge. Organic build up is visible along the gutter channel which may, over time, restrict rainwater flow if not maintained.

No visible signs of overflow, staining, or active drainage failure were observed at the time of inspection. This is considered a routine maintenance matter, and clearance of the guttering is recommended to ensure effective rainwater discharge.

Moss accumulation within the guttering Photo A2 requires routine maintenance clearance.

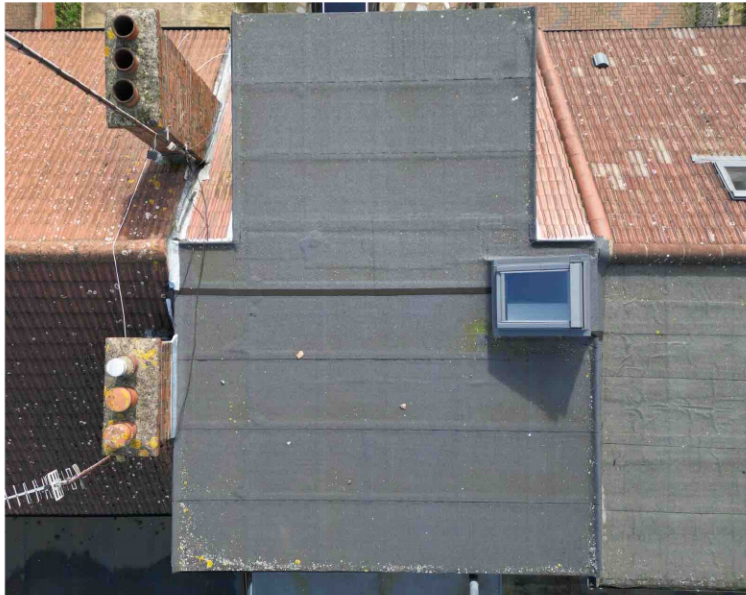
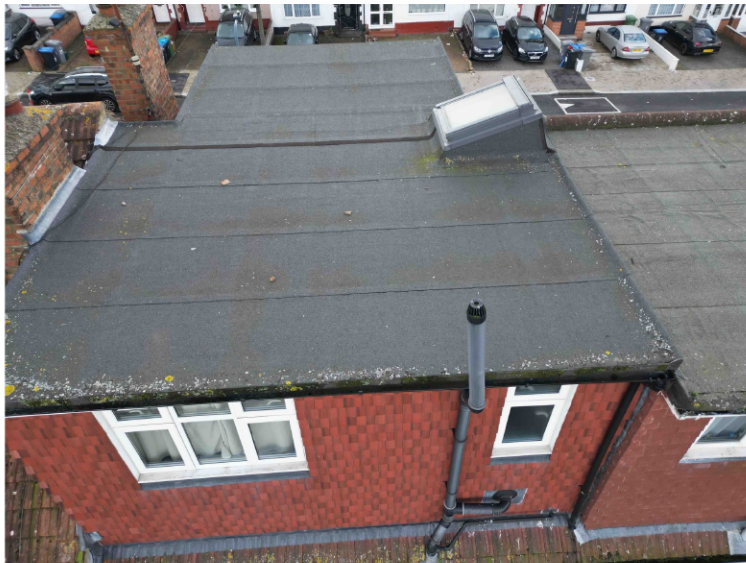
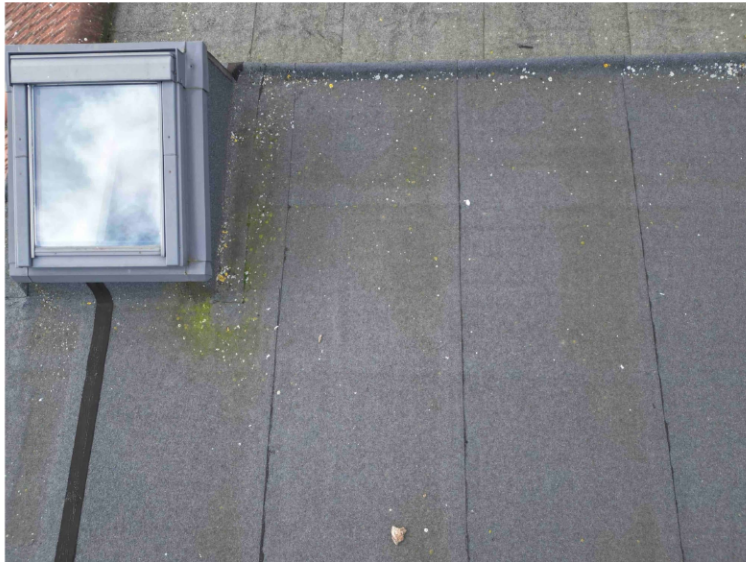
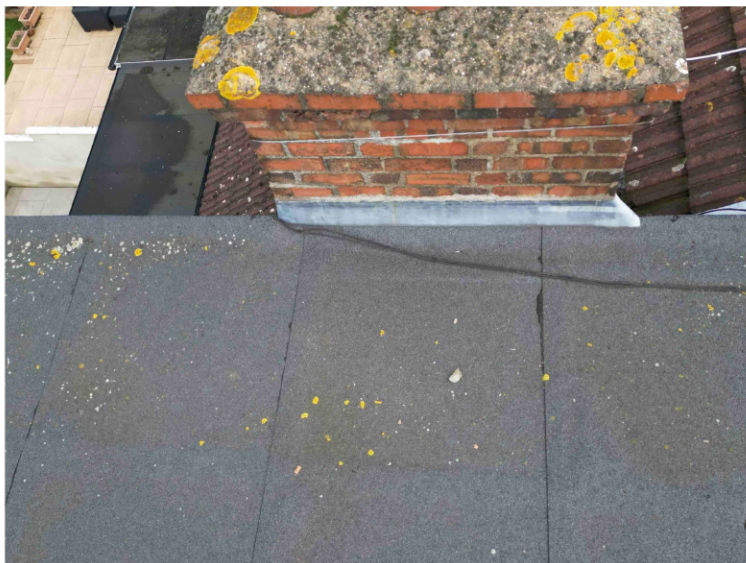
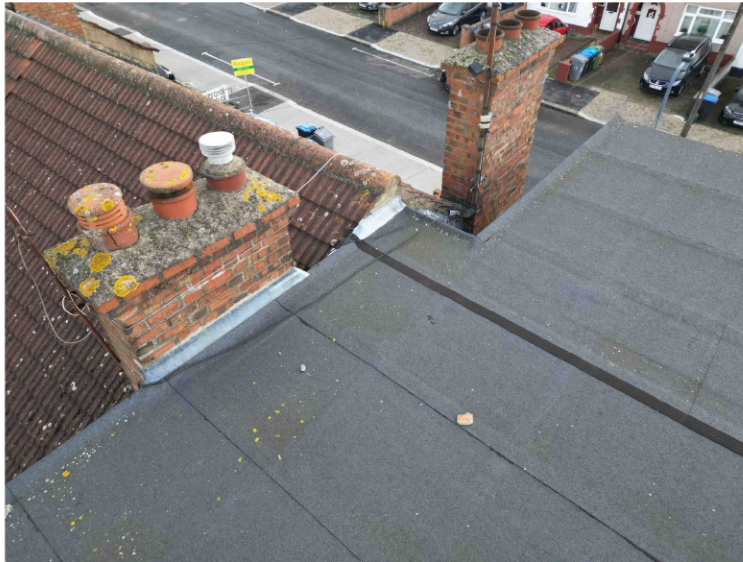
## Overview Photographs

The flat roof covering appears evenly laid and generally in good condition. Based on the aerial imagery supplied, the following common flat roof defects were not observed:

- No blistering or bubbling of the felt membrane
- No ponding or standing water
- No open lap joints or seam separation
- No cracking, splitting, or membrane shrinkage
- No evidence of wind blow over
- No exposed bitumen or significant ultraviolet deterioration
- No flashing failure at chimney abutments
- No visible structural sagging or deck deflection

Lead flashing details around the chimney stacks appear intact and appropriately dressed. The mineral surface finish remains consistent across the visible areas.
