**Roof Type:** Flat

We were required to conduct a targeted inspection to identify the likely sources of water ingress affecting two specific zones (referred to as Area 1 and Area 2) of the upper roof structure. The objective was to assess the drainage system, structural surfaces, and joint seals to determine whether any visible roof level defects could be contributing to water penetration into the flats below.

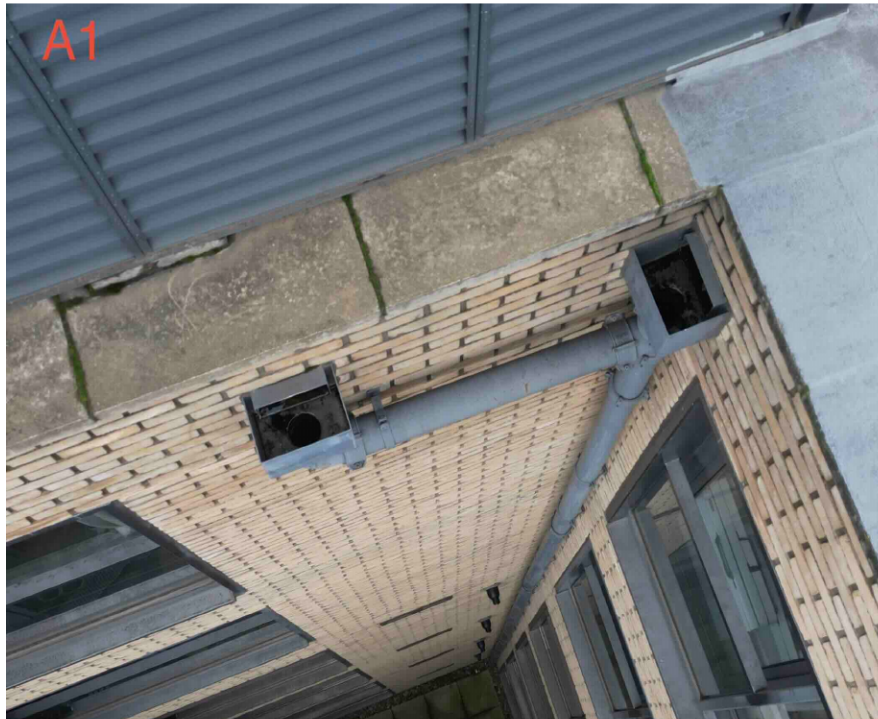
(Photo A1)

The hopper outlets for the downpipe appear unobstructed and free from debris. There is no visible staining or discolouration on the adjacent brickwork, which would typically indicate overflow or leakage from the downpipe itself. The structural connection between the pipe and hopper appears intact, with no evident breaks or displacement.

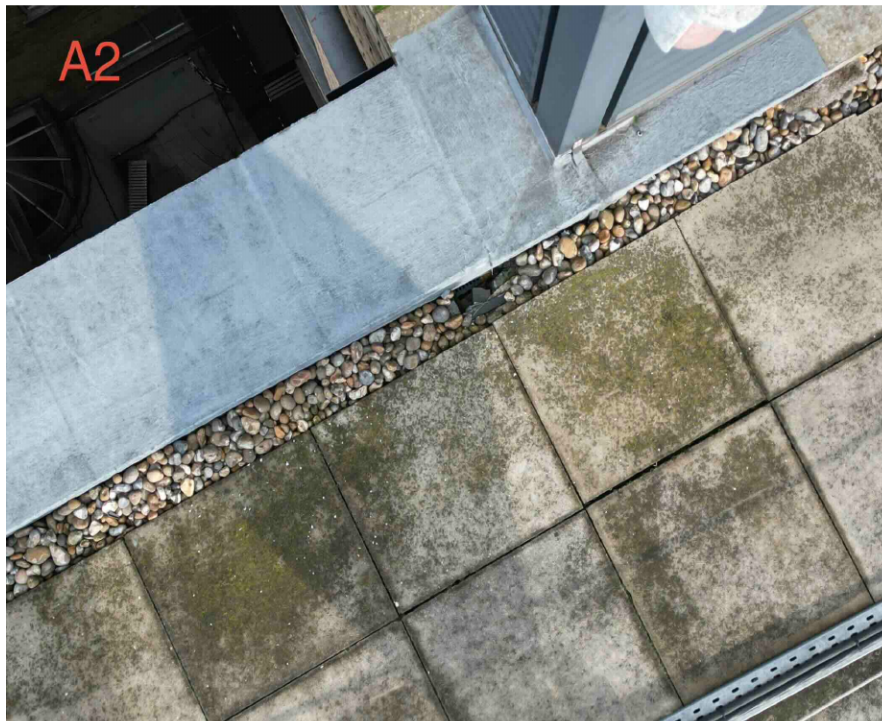
(Photo A2)

A pebble drainage margin has been incorporated adjacent to the upstand, with a presumed drainage channel beneath. However, the surface gravel is loosely dispersed, and the slabbed surface adjacent to it is displaying widespread biological staining, which may be suggestive of poor drainage or prolonged surface moisture retention. This warrants further investigation into whether the subsurface drainage is functioning correctly.

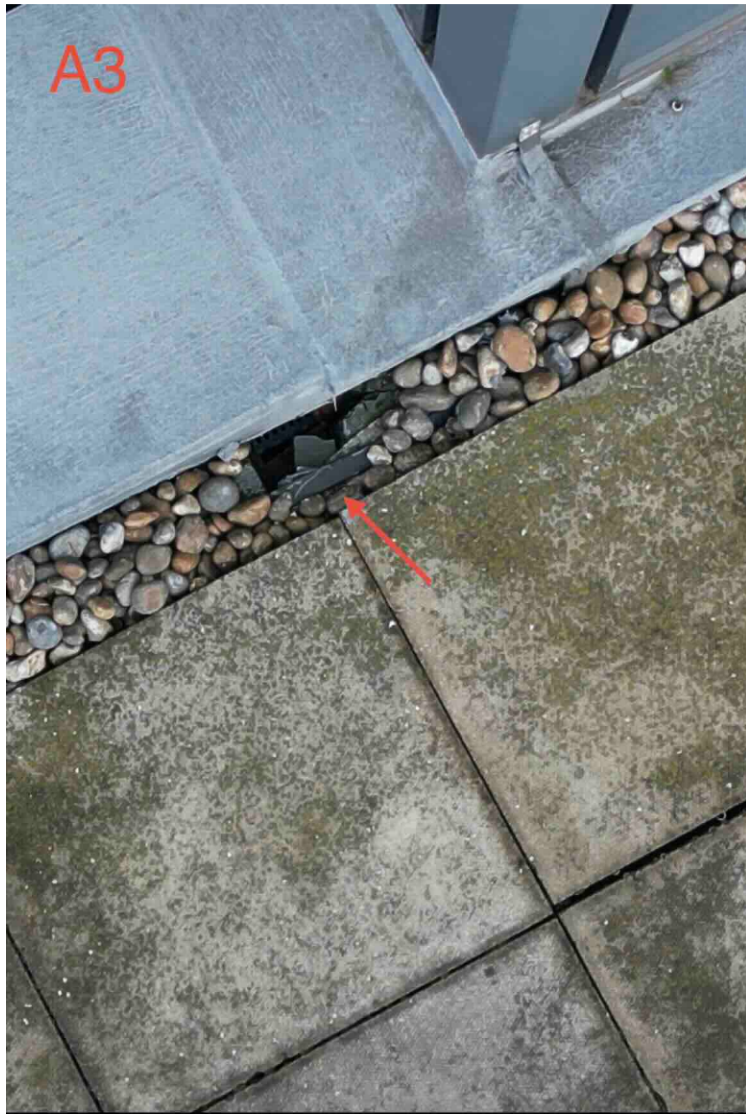
(Photo A3)

A close up of the gravel trench reveals what appears to be a section of dislodged or fractured shingle, potentially obstructing the concealed drain outlet beneath. This could be redirecting water horizontally rather than vertically into the drainage system. The build up of debris may be partially restricting effective drainage into the pipe network.

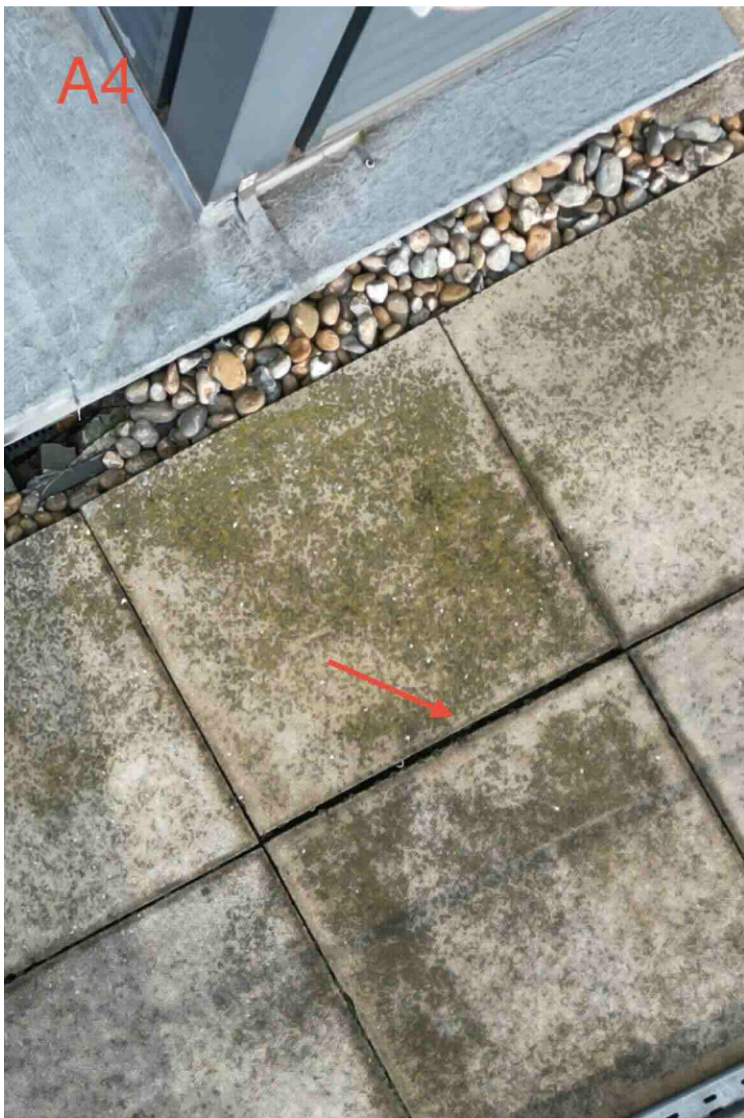
(Photo A4)

Evidence of algal growth is visible along the paving slabs, with notable dark staining around slab joints. The joint pointing between slabs is visibly degraded and unsealed in parts, providing a potential ingress route for standing water. This combination of algae growth and open slab joints directly above internal areas of concern strongly suggests that water may be percolating through the substrate and entering the flat below. In our opinion, the ponding water and poor pointing are the likely culprits in this section.

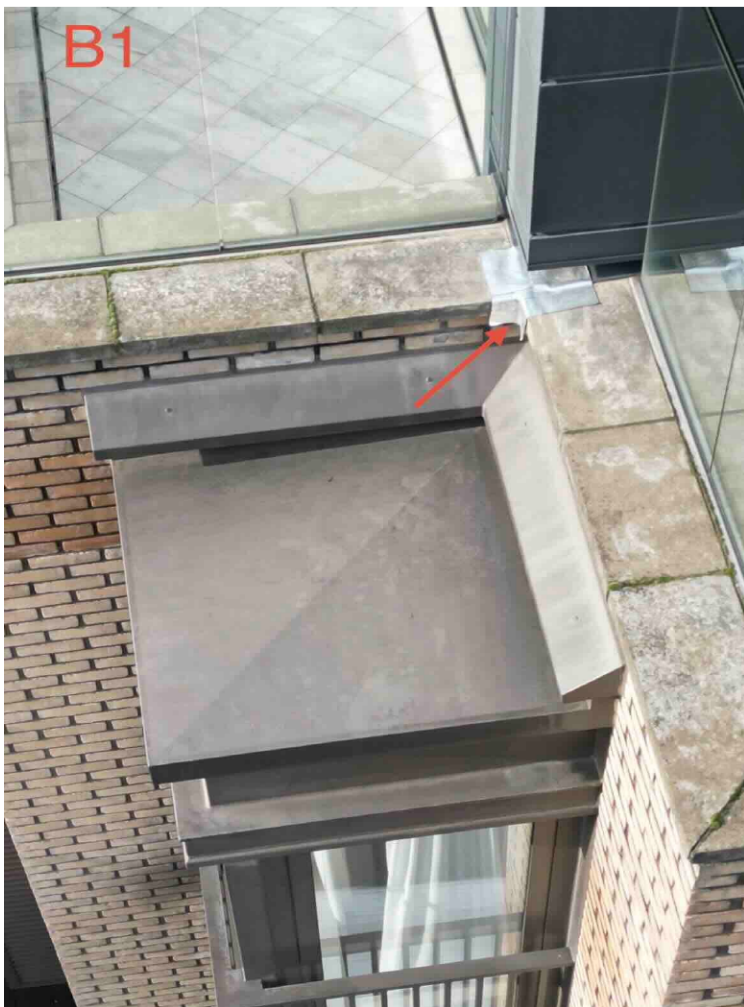
(Photo B1)

Visible along the edge coping is an applied flashing tape which appears to have been installed as a remedial measure over the coping stone joints. The workmanship appears rudimentary and not consistent with standard roofing practice. Notably, there is no continuous seal beneath the coping stone visible from this vantage point. Dark staining on the stone suggests water absorption or retention, which may be occurring beneath the surface of the tape, rendering the attempted seal ineffective.

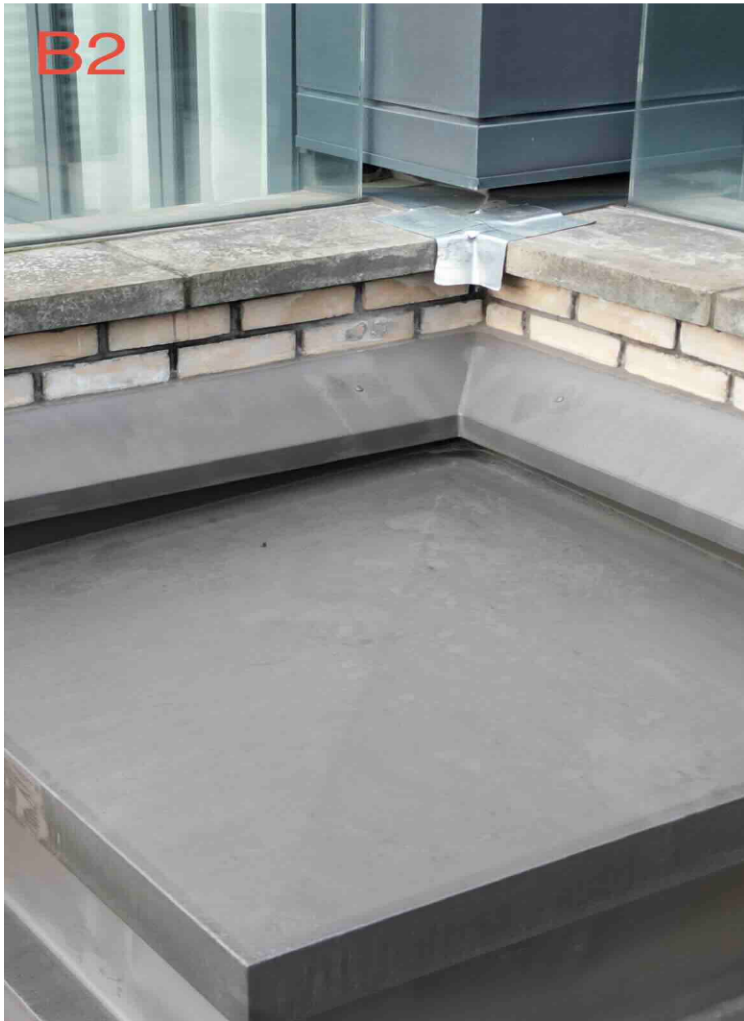
(Photo B2)

This image provides further visual clarity of the applied tape seal. The flashing overlaps are poorly bonded to the stone surface and exhibit no sign of a heat sealed or mechanically fixed termination. The applied flashing is unlikely to withstand long term exposure to rain and UV, particularly at the joint returns. This likely points to ongoing water ingress through failed coping joints, with direct vertical travel into the external cavity wall and subsequently into the flat below. A more robust sealing method such as continuous torch applied bitumen flashing or resin-based mortar is recommended.
