**Client:** W

**Roof Type:** Flat & Slate

**Date & Time:** 24th July 2026 - 11:00hrs

## PURPOSE OF THE INSPECTION

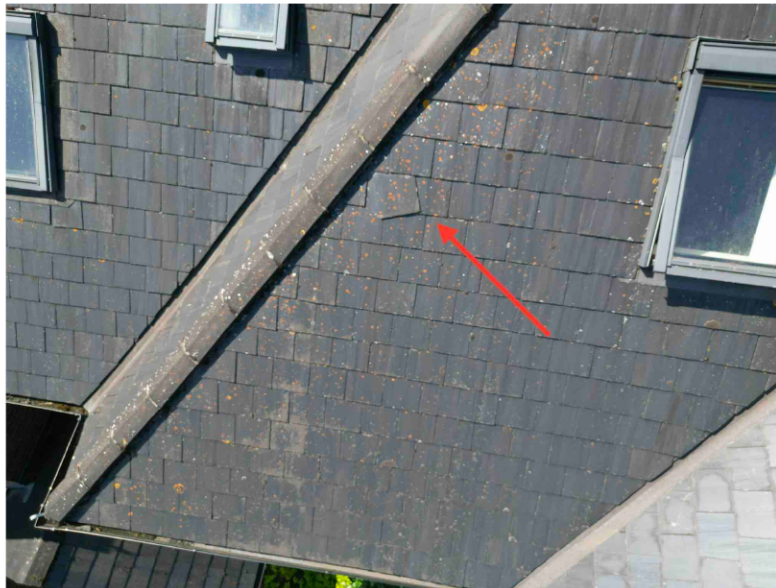
Photo 1

A slipped slate tile was observed adjacent to the lower dormer roof. The displacement has reduced the intended overlap between the surrounding slates, creating a vulnerable point where rainwater may penetrate beneath the roof covering.

Continued exposure to the elements may allow moisture to reach the roofing underlay, supporting battens and roof timbers, increasing the likelihood of internal dampness and gradual deterioration. Minor weathering together with light lichen growth was also noted across this roof slope, which is consistent with the age of the roof and is not considered a cause for concern at this stage.

It is recommended that the slipped slate tiles are reinstated using suitable fixings and that all missing slate tiles are replaced with matching materials to restore the continuity of the roof covering.

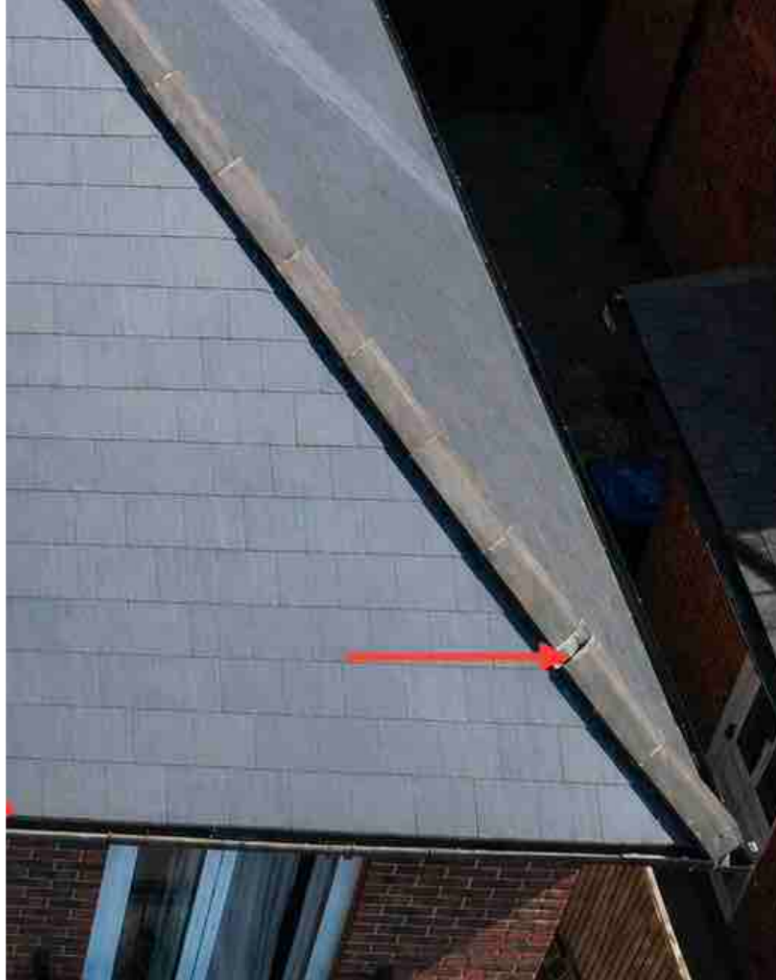
Photo 2

A section of missing mortar pointing was observed beneath the ridge line, leaving a visible opening between the ridge tiles. The loss of mortar has reduced the effectiveness of the ridge as a weather resistant barrier and may permit wind driven rain to penetrate beneath the ridge tiles. If this deterioration continues, additional mortar loss may occur, reducing the stability of the ridge tiles and increasing the likelihood of future movement during periods of adverse weather.

The defective ridge pointing should be carefully removed and repointed using an appropriate roofing mortar to reinstate the weatherproof seal and maintain the long term stability of the ridge.

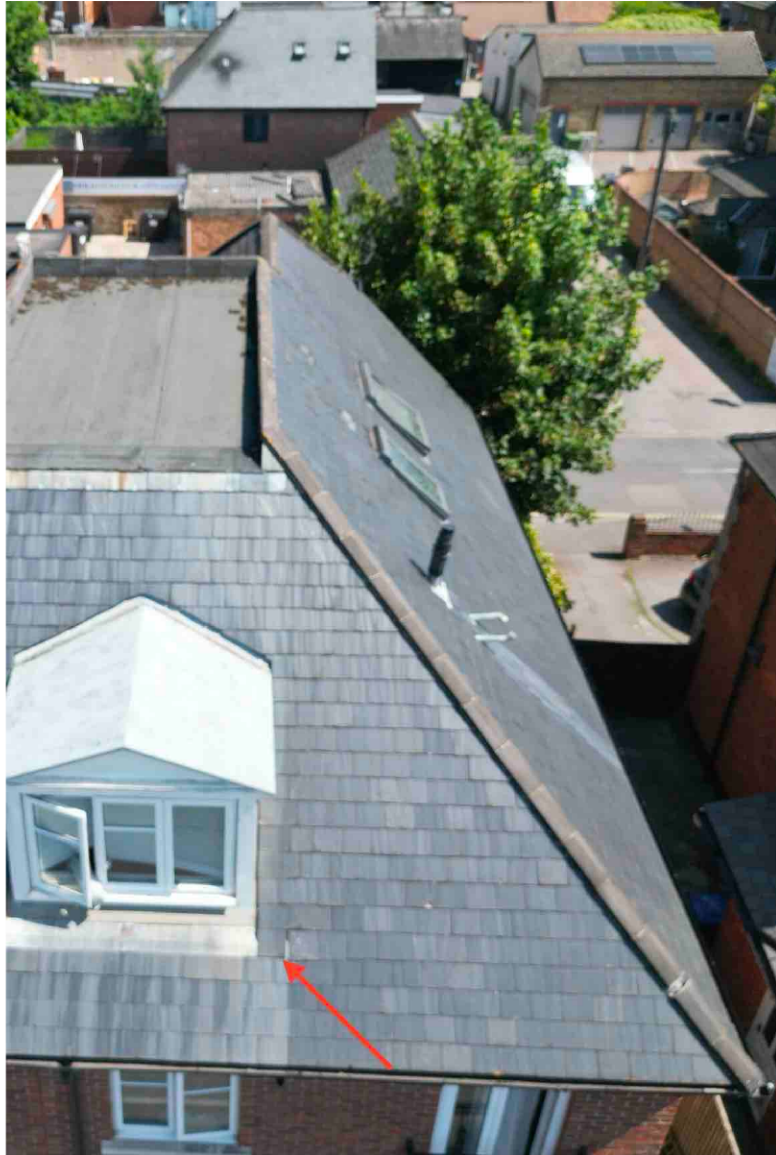
Photo 3

A slipped slate tile was observed immediately adjacent to the dormer abutment. The movement has reduced the effective overlap of the surrounding slates, increasing the potential for water ingress at a location naturally subjected to concentrated rainfall. Moisture entering this area over an extended period may affect the supporting timbers, roof underlay and internal finishes.

The lead flashings surrounding the dormer remain securely dressed and no visible evidence of separation, lifting or deterioration was observed during the inspection.

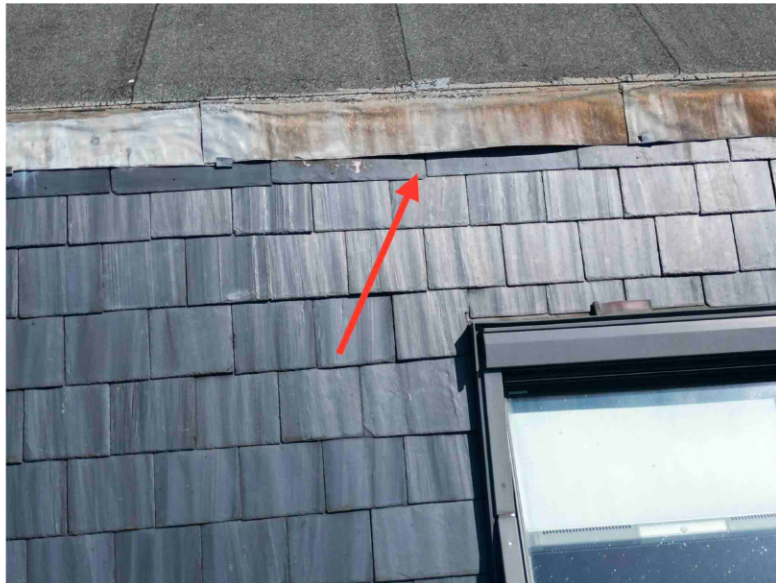
Photo 4

The lead flashing adjacent to the flat roof upstand has lifted away from the adjoining roof covering, reducing the effectiveness of the weatherproof seal. This opening may allow rainwater to track beneath the flashing during periods of wind driven rain, increasing the likelihood of damp penetration into the roof structure.

Ongoing thermal expansion and contraction may result in further lifting if the flashing is not correctly re dressed and secured.

The raised lead flashing should be correctly re dressed and securely fixed to ensure an effective weather resistant seal is restored and to prevent further movement caused by thermal expansion.

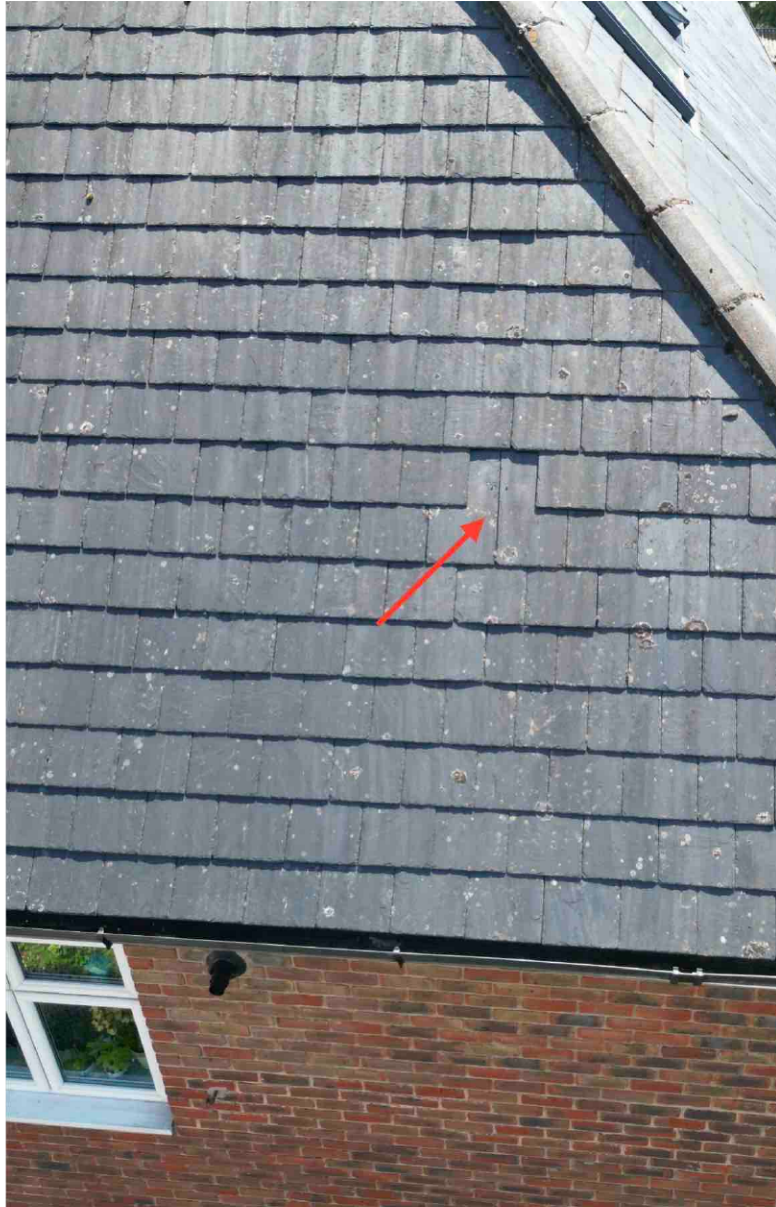
Photo 5

A missing slate tile was observed on the upper roof slope, leaving the underlying roof construction exposed to the elements. This opening provides a direct route for water ingress and may lead to deterioration of the roofing underlay, battens and supporting timbers if left unrepaired.

The surrounding slates remain correctly aligned, suggesting this is currently an isolated defect rather than evidence of widespread movement.

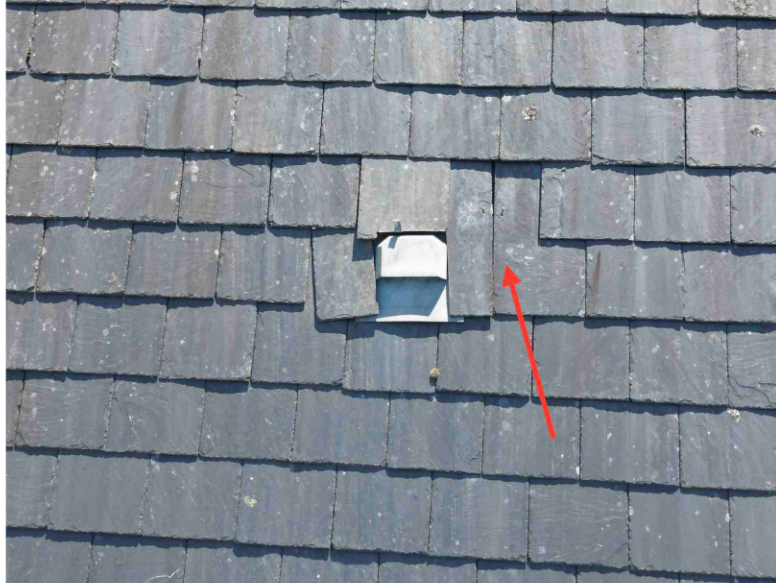
Photo 6

Another missing slate tile was observed adjacent to a roof vent terminal. The exposed opening interrupts the continuity of the roof covering and provides a route through which water may penetrate beneath the surrounding slates.

Prolonged exposure to moisture may result in timber decay, internal staining and gradual movement of neighbouring slates, particularly during periods of severe weather.

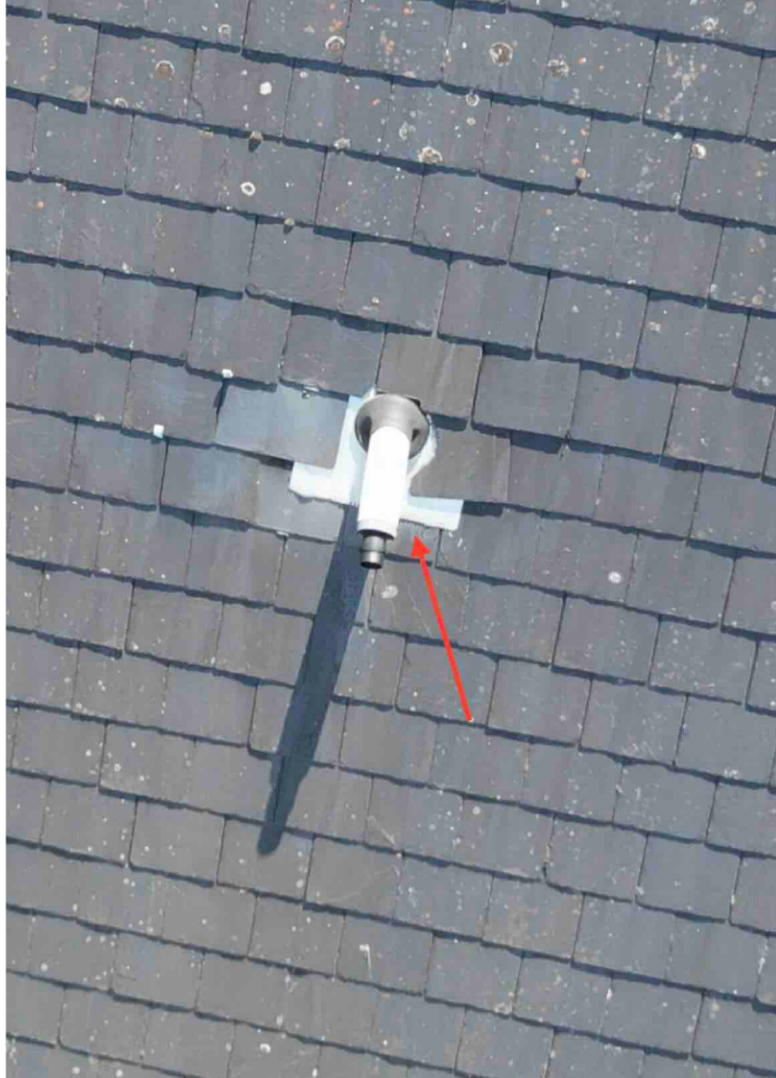
Photo 7

The roof vent penetration is surrounded by several slate tiles that appear displaced or inadequately seated, creating gaps around the flashing detail. Whilst the vent flashing remains present, the uneven positioning of the adjacent slates may allow wind driven rain to penetrate beneath the roof covering. It is recommended that the affected slates are secured and correctly aligned.

If left unremedied, this defect may result in water ingress to the underlying roof structure, leading to dampness, timber deterioration and internal staining. Continued exposure to adverse weather conditions may also cause further displacement of the surrounding slates, increasing the risk of more significant water penetration.

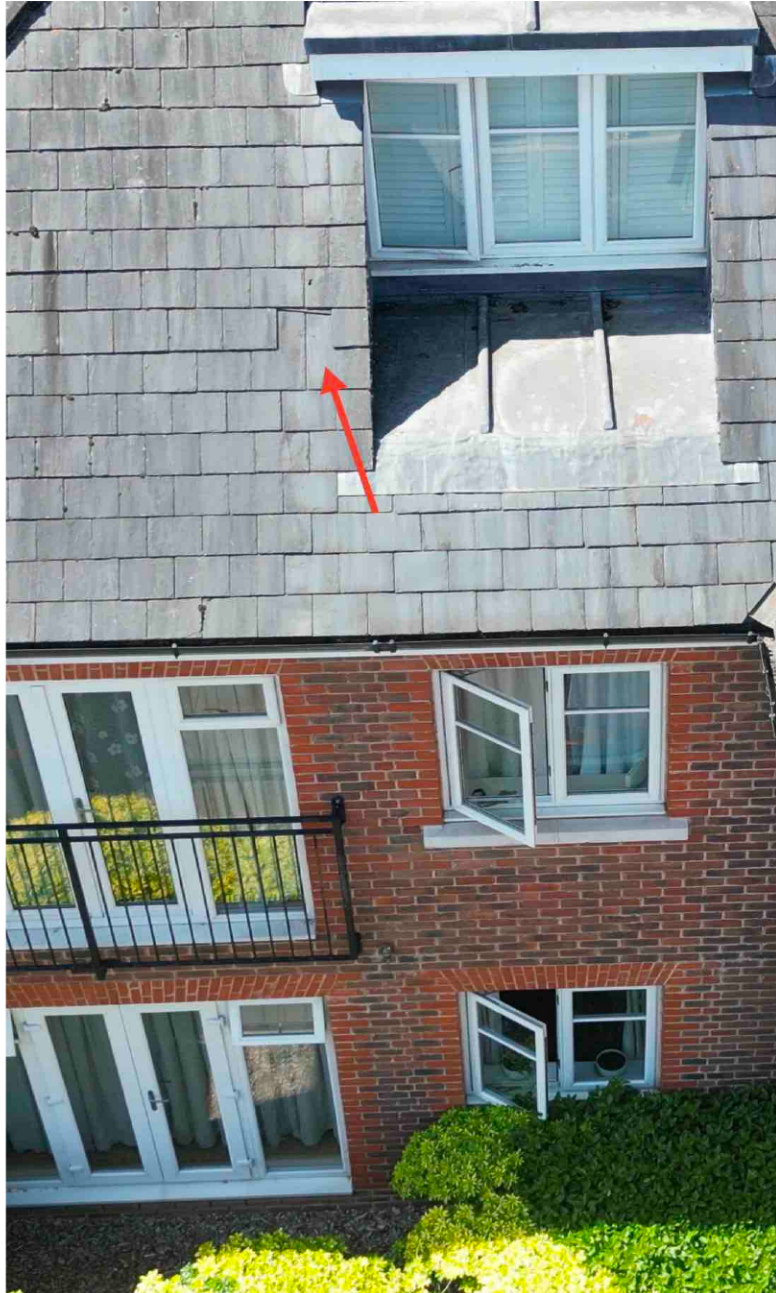
Photo 8

A missing slate tile was observed adjacent to the dormer cheek. This defect exposes the underlying roof construction in an area where rainfall naturally collects around the dormer abutment.

Continued water penetration may result in deterioration of the roof battens, roofing underlay and dormer structure. The surrounding slate covering remains secure and correctly aligned with no visible evidence of widespread movement across this roof slope.
