**Roof Type:** Bitumen Felt/Mastic Asphalt/Slate

**Date & Time:** 19th Dec 2025 - 10:17hrs

## Inspection Purpose

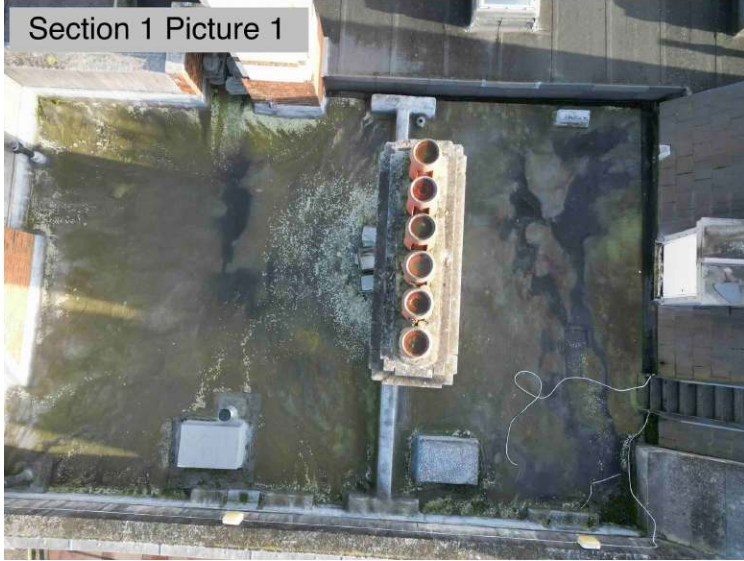
Section 1 Picture 1

**(Section 1 – Picture 1)** The mastic asphalt surface remains sealed but has become uneven due to long term weathering. This has resulted in minor water retention and moss development.

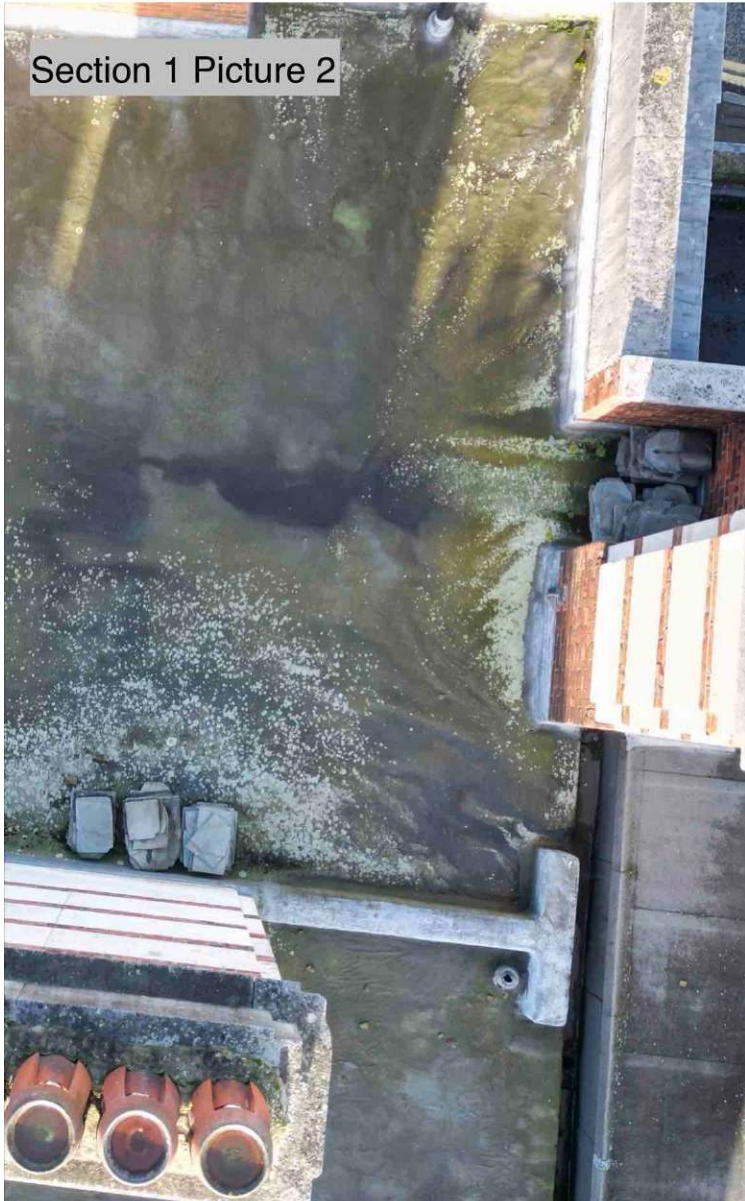
Section 1 Picture 2

**(Section 1 – Picture 2)** A group of unused tiles has been stacked on the roof, potentially contributing to water pooling or acting as debris traps.

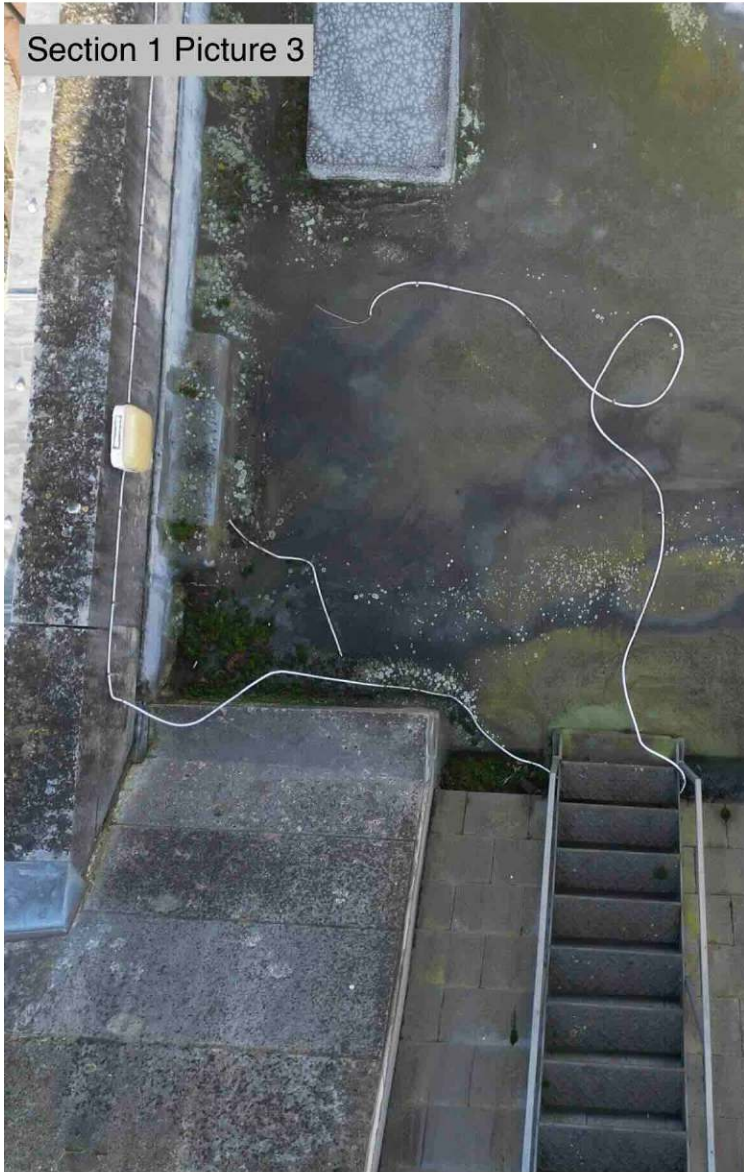
Section 1 Picture 3

**(Section 1 – Picture 3)** One exposed roof light cable has been noted. It appears severed or disconnected, possibly from a decommissioned system. Its loose and untidy presentation could pose a hazard.

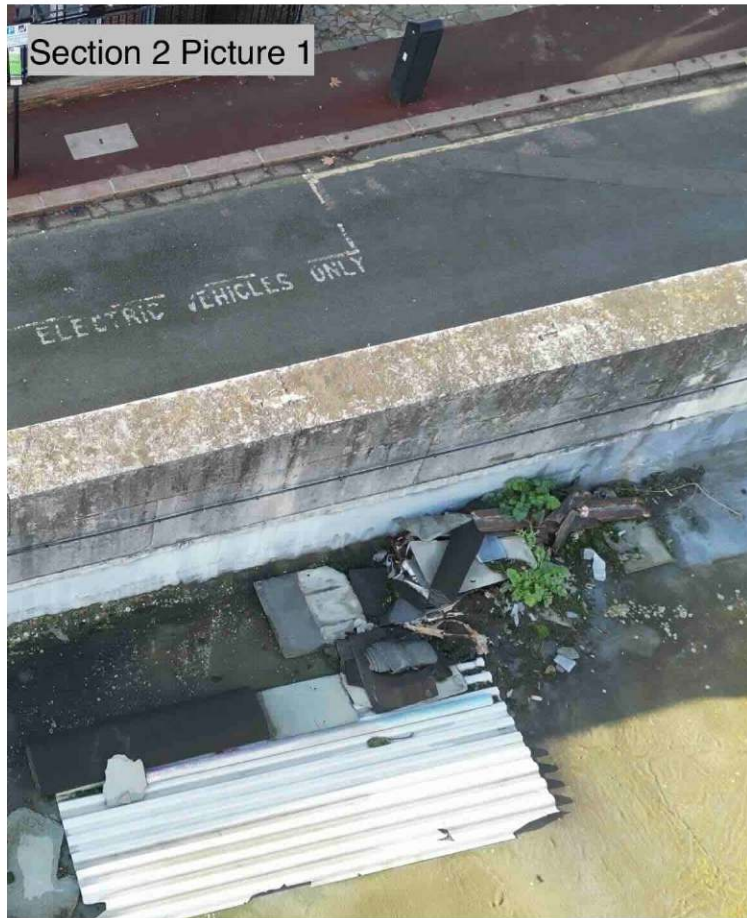
**(Section 2 – Picture 1)** A sheet of corrugated material (either plastic or metal) has been left on the rooftop. It may have originally been used to cover an opening or egress point, but it now poses a potential wind hazard. There is also a surrounding accumulation of debris and vegetation.

We recommend the removal of the loose corrugated sheet to mitigate the risk posed during periods of high winds. In addition, the repointing works to Chimney H, the repair works to Chimney F, and the repairs to Skylights A and D should be monitored and re-evaluated during future inspections.

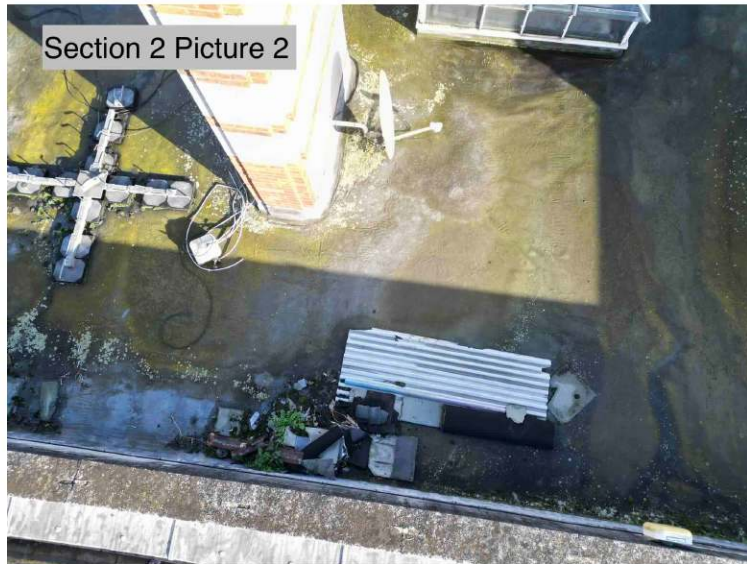
**(Section 2 – Picture 2)** The mastic asphalt surface has signs of weathering, with surface undulation and moss growth present. Minor pooling is visible in several low points.

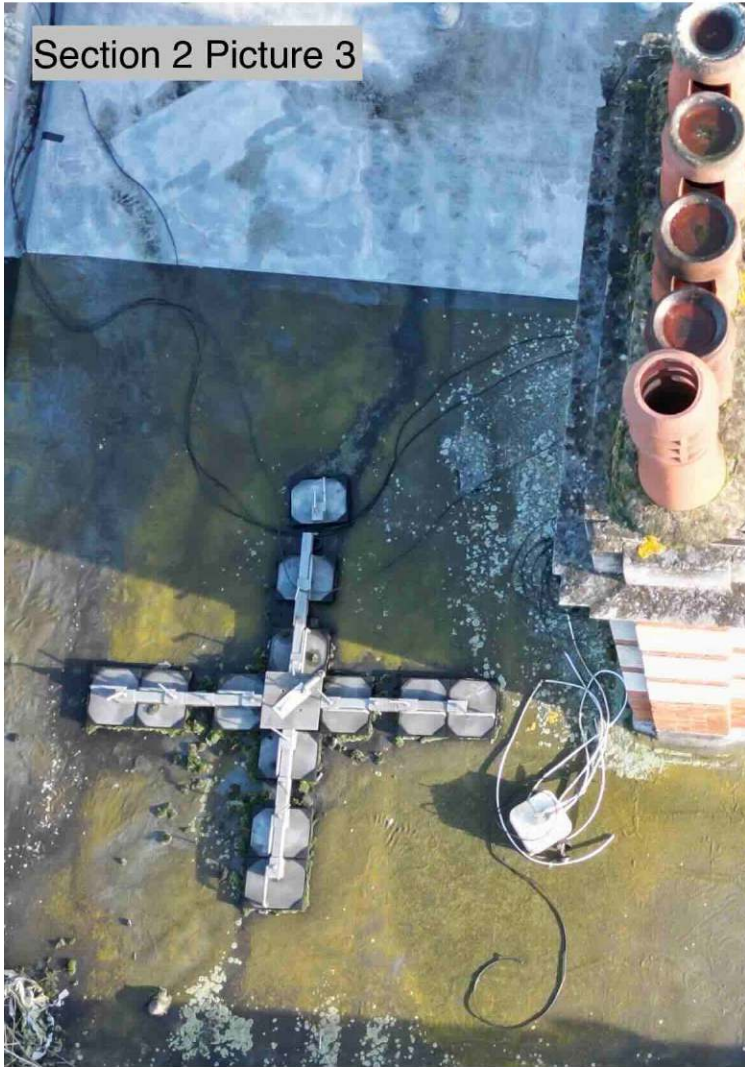
Section 2 Picture 3

**(Section 2 – Picture 3)** Wiring associated with the aerial and satellite installations is messy and loosely arranged.

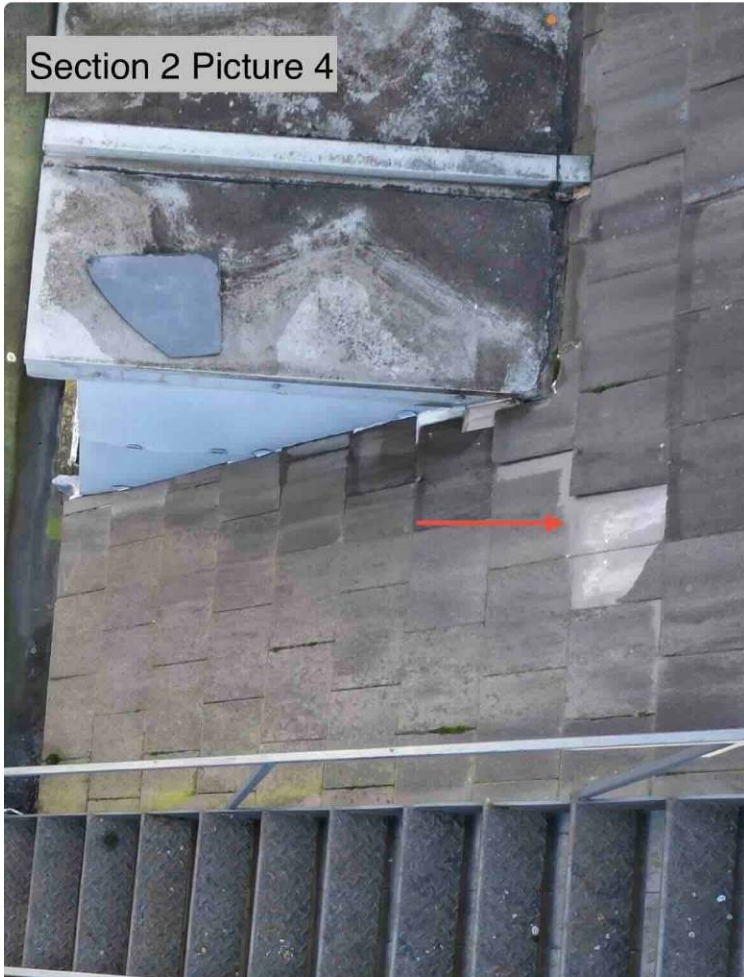
Section 2 Picture 4

**(Section 2 – Picture 4)** One tile is missing from the pitched roof area, and it has slid down and is visible in the image. Apart from this, the remainder of the pitched roof appears to be in good condition.

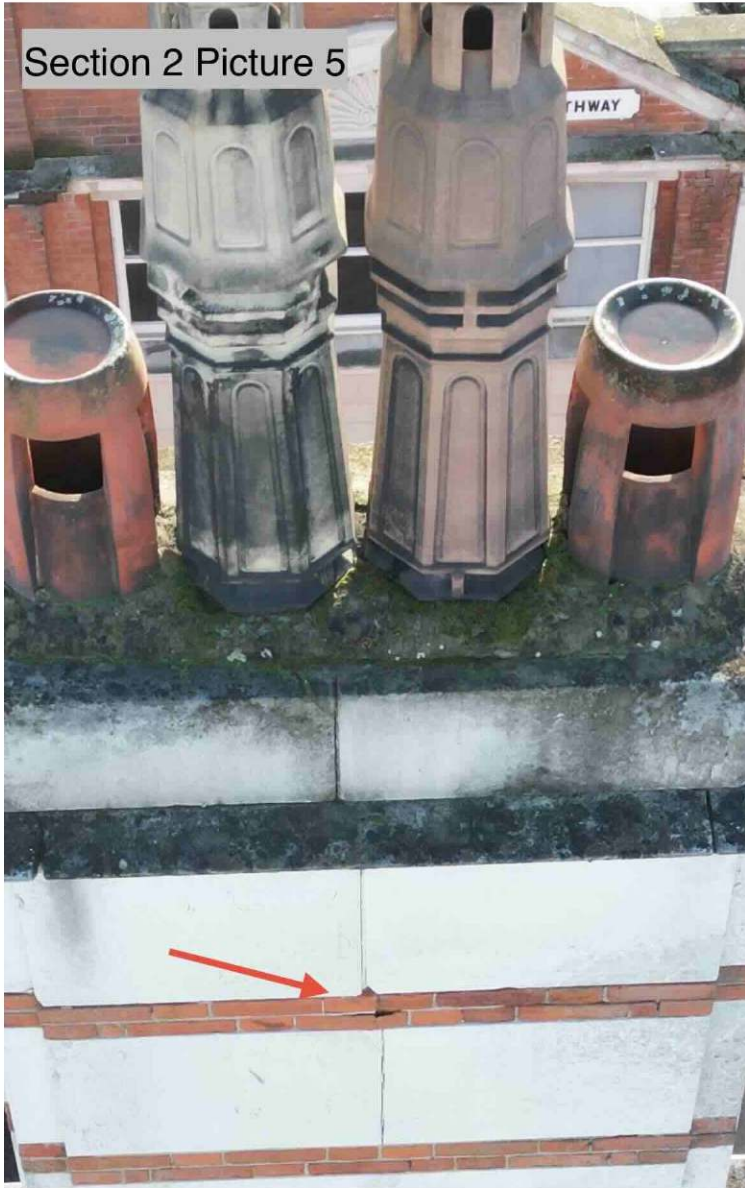
Section 2 Picture 5

**(Section 2 – Picture 5)** Chimney F has a visible large vertical crack and a partially fractured brick, both located on the interior-facing wall of the stack.

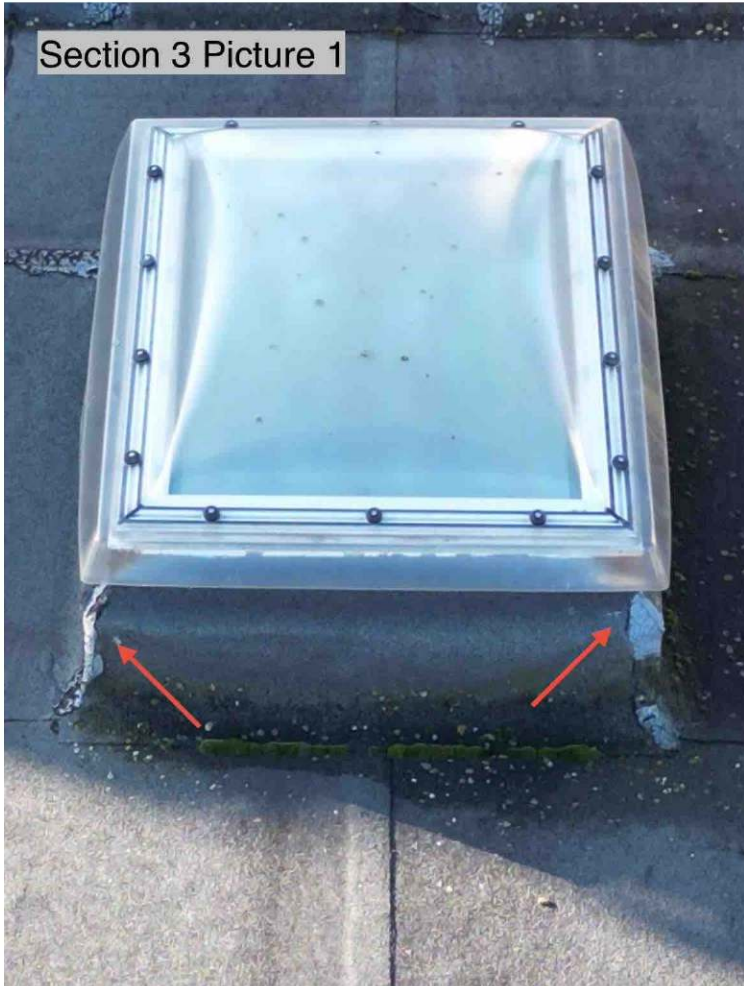
Section 3 Picture 1

**(Section 3 – Picture 1)** Skylight A shows signs of a previous repair, specifically around the sealed corners. The sealing compound has degraded and begun to erode, which may allow water ingress if not addressed.

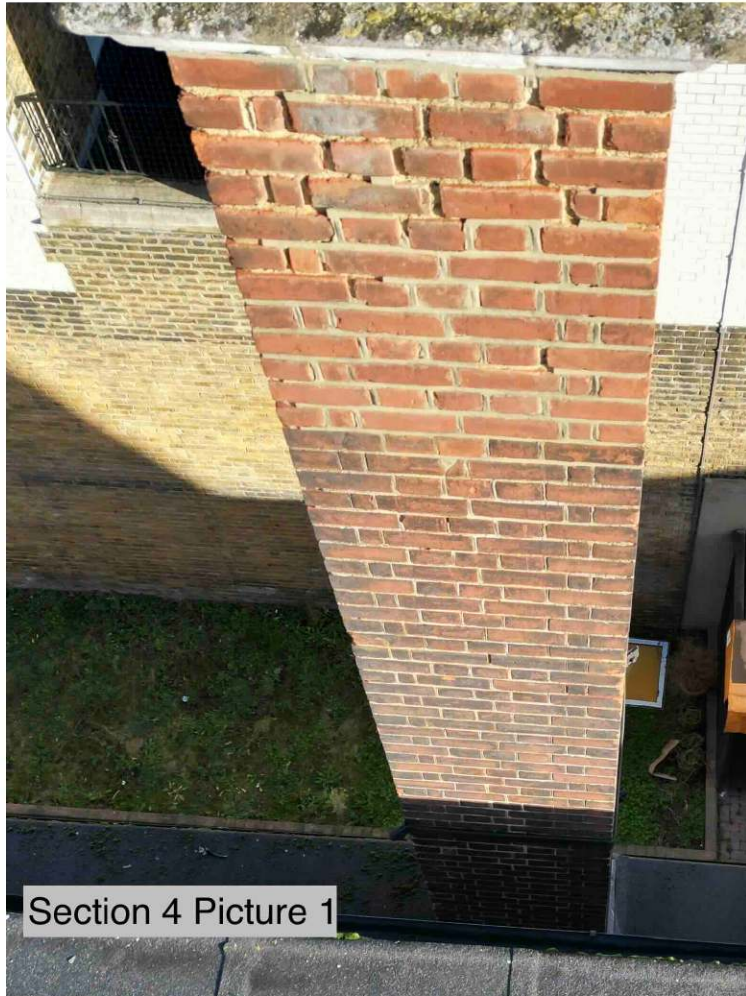
Section 4 Picture 1

**(Section 4 – Picture 1)** Chimney H appears structurally sound, although the pointing at the inner facing top area is deteriorating and would benefit from repointing in due course.

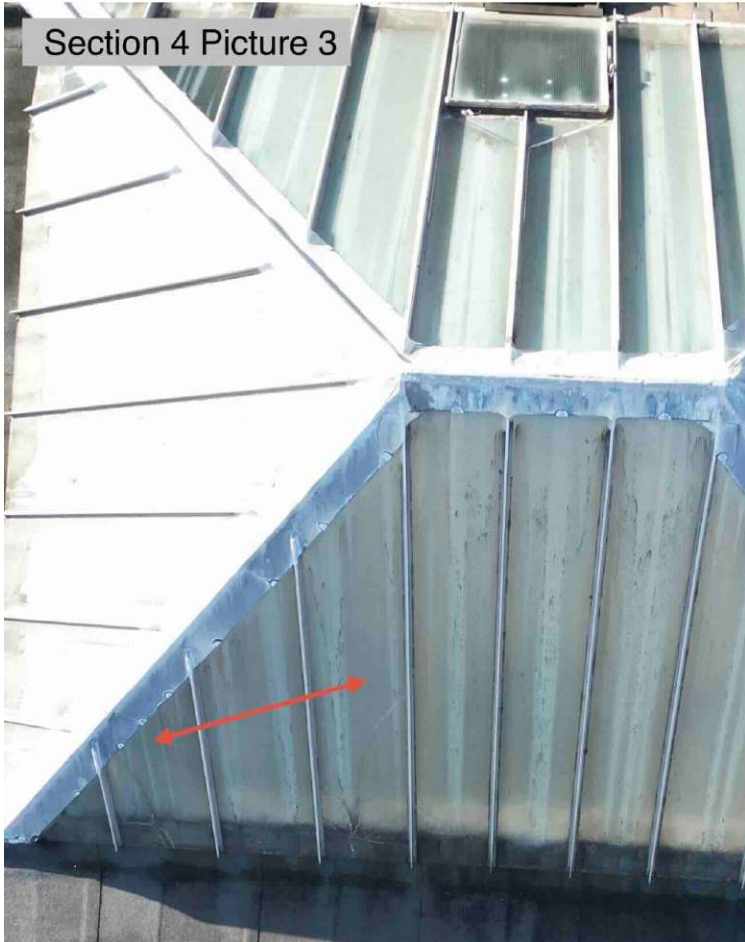
Section 4 Picture 3

**(Section 4 – Picture 3)** The large glazed roof lantern shows several cracks to the glazing. Despite this, the lantern remains sealed and secure around the perimeter, and no active leaks are currently evident. Water run-off points in this area appear securely bonded and there are no visible obstructions or deterioration.

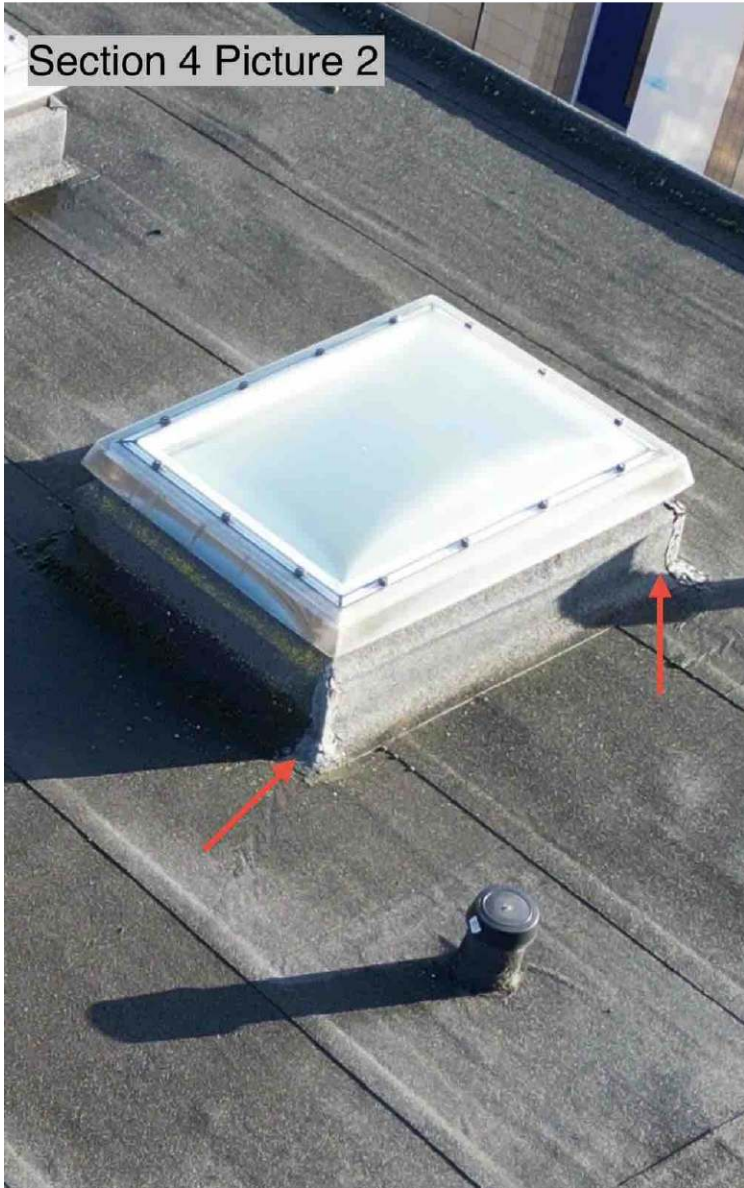
Section 4 Picture 2

**(Section 4 – Picture 2)** Skylight D has a previously sealed repair to the edge frame, similar to Skylight A. The sealing work appears to be ageing.

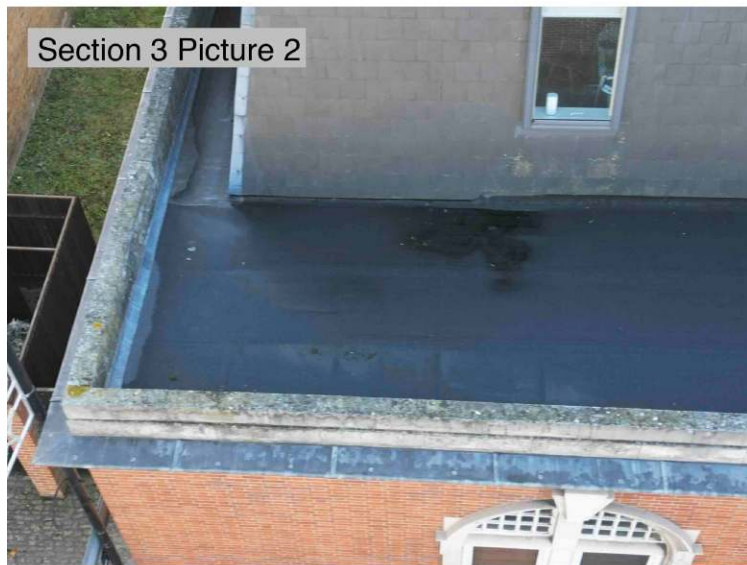
(Section 3 – Picture 2) The lower elevation of the roof, covering the transition between Sections 3 and 4, shows minor water pooling.
