## Overview

The images provided show a section of a roof with solar panels installed. While the roof structure itself appears mostly intact, there are visible signs of wear and the presence of debris, biological growth, and potential obstructions. The solar panels also exhibit a significant accumulation of debris and dirt, which could impact their efficiency.

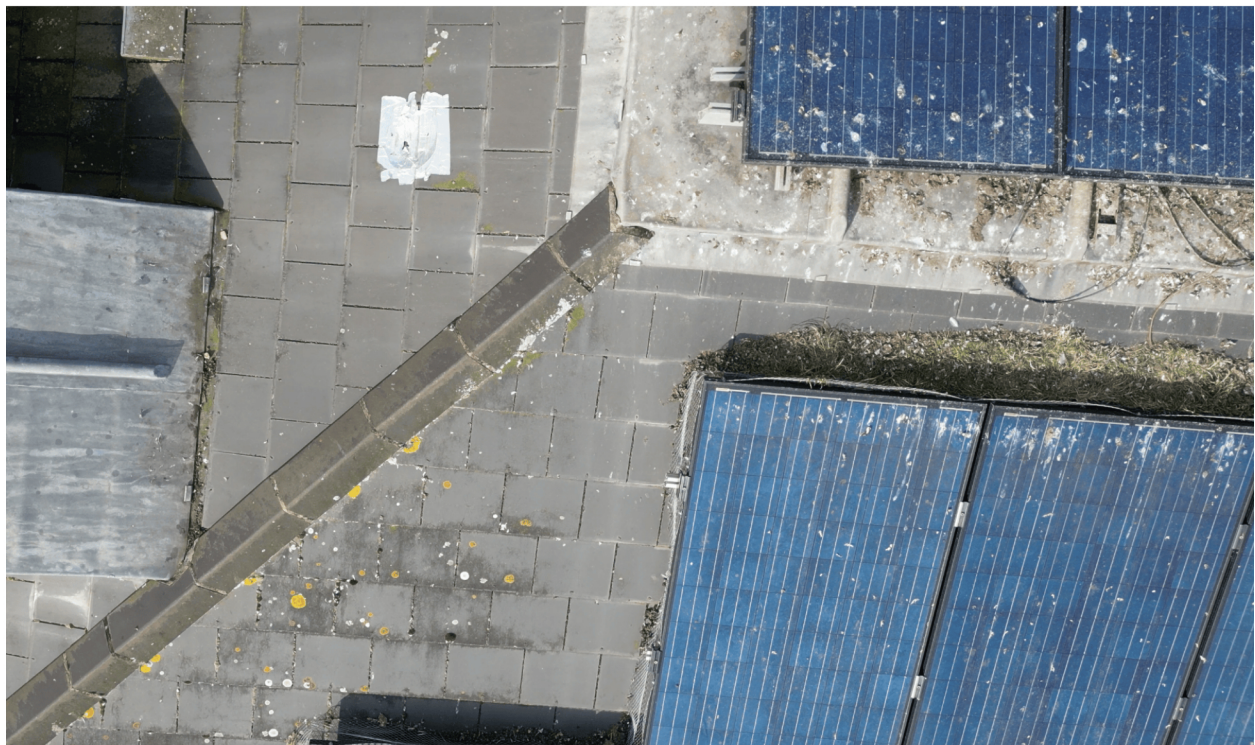
- **Image B1** and **Image B2** show sections of the roof with slate tiles that appear generally intact but exhibit notable moss and lichen growth in several areas. This biological growth is especially visible near the joints and on the slopes of the roof, which may retain moisture and accelerate tile deterioration over time.
- There is a patch in **Image B1** that appears to be covered with some form of repair material, likely applied to address a previous defect. While this seems to be a temporary fix, a more thorough repair may be needed to prevent further damage.
- **Image B2** shows patches of discolouration and dirt accumulation, indicating that these areas have been subject to environmental exposure for an extended period.

- The patch identified in **Image B1** should be reviewed to ensure the underlying issue has been fully resolved, and a more permanent solution should be considered if necessary.
- Regular cleaning of the moss and lichen on the roof tiles is recommended to prevent long-term deterioration.

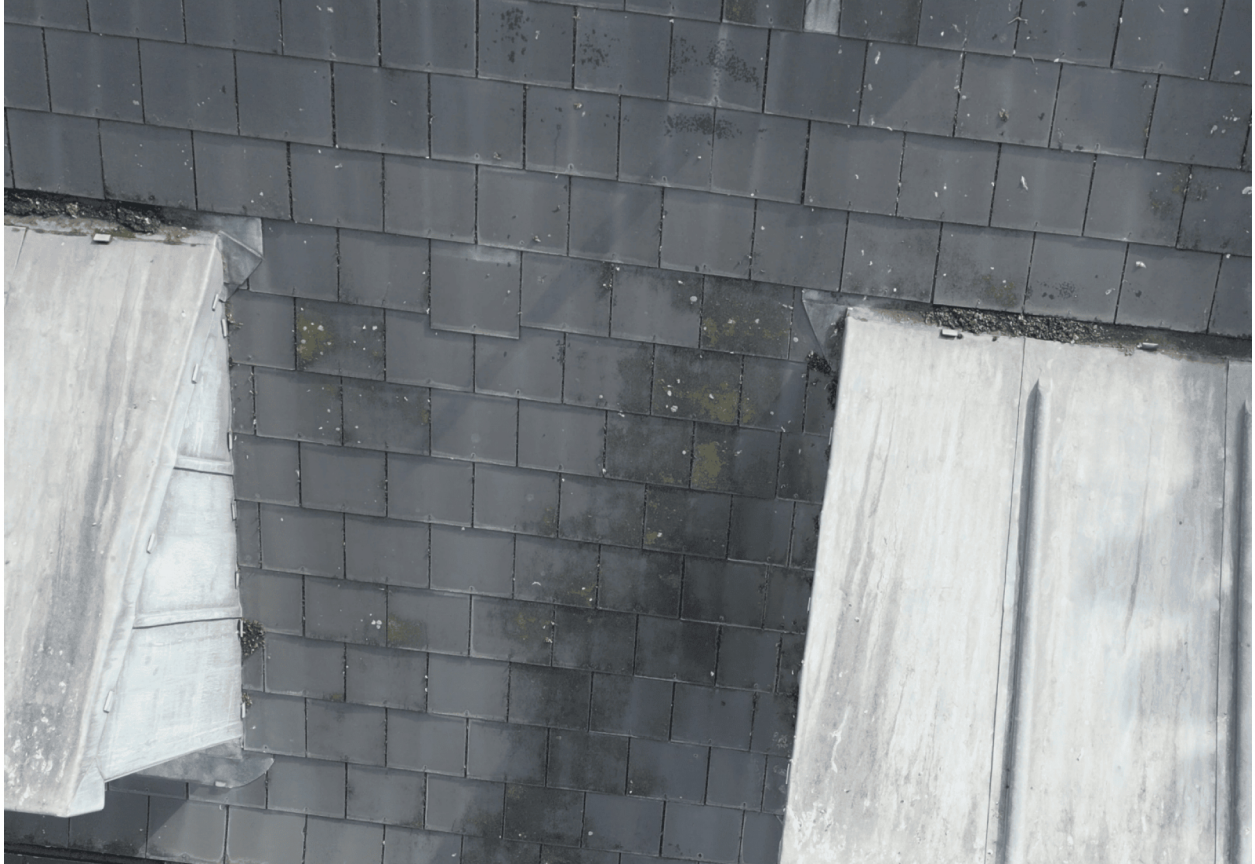
- Moss and lichen are present on both the roof surface and around the edges of the solar panels, particularly in **Image B2**. This growth, if left unchecked, can contribute to moisture retention and degrade the roofing materials beneath the panels. Regular cleaning of both the roof and the solar panels will help prevent the build-up of this growth and preserve the integrity of the structure.

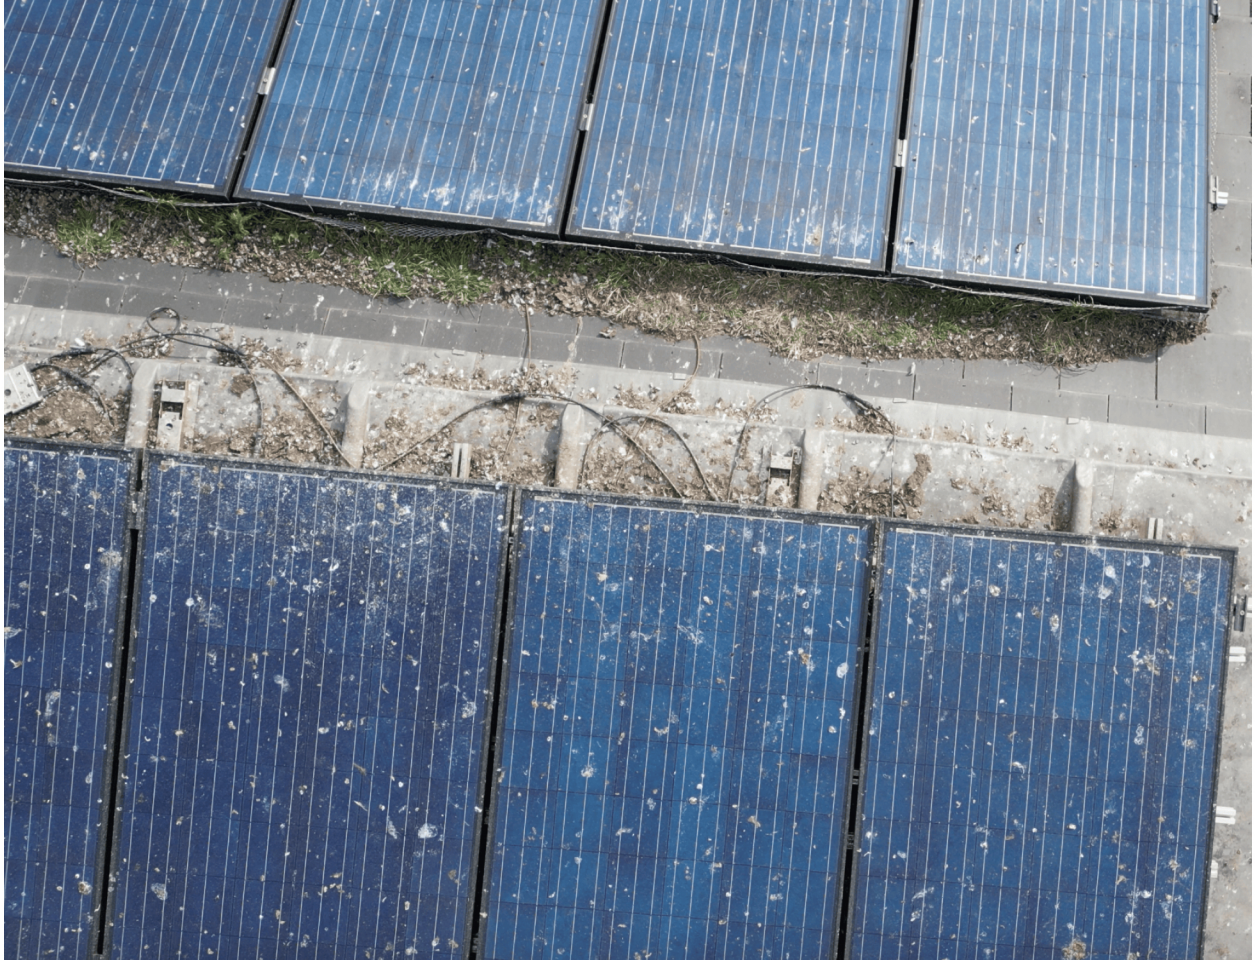
- **Images B3** and **B4** display solar panels covered in a considerable amount of debris, dirt, and bird droppings. This accumulation can severely impact the efficiency of the panels by blocking sunlight and reducing energy output. It is vital to have the panels cleaned regularly to maintain optimal functionality.
- Additionally, some wiring and mounting points beneath the panels, visible in **Images B3** and **B4**, appear to be exposed to environmental factors. This could lead to potential damage over time, and an inspection of the mounting and wiring system is recommended to ensure everything is securely fastened and protected from the elements.

- The gutters and drainage channels, especially visible in **Image B3** and **B4**, appear to have accumulated leaves, dirt, and possibly bird droppings. If not cleared, this debris could obstruct water flow during rain, leading to potential overflow and water ingress issues.

- The dirt and debris accumulation on the solar panels should be cleaned as soon as possible. This will help restore the panels' efficiency and prevent any damage caused by the build-up of bird droppings, which are acidic and can degrade the panel surface over time.

- Ensure that the drainage system is free from debris to allow for proper water run-off. This is especially important given the dirt accumulation visible in **Image B3**.

- Inspect the solar panel mounts and wiring, as shown in **Image B3** and **B4**, to ensure that everything is securely in place and protected from environmental exposure. Consider additional weatherproofing if necessary.
